ENGINEER'S REPORT

CORROSION ENGINEERING EVALUATION

WELDED STEEL HYDRO-PNEUMATIC TANK
(BLACK LAKE)

NIPOMO, CALIFORNIA

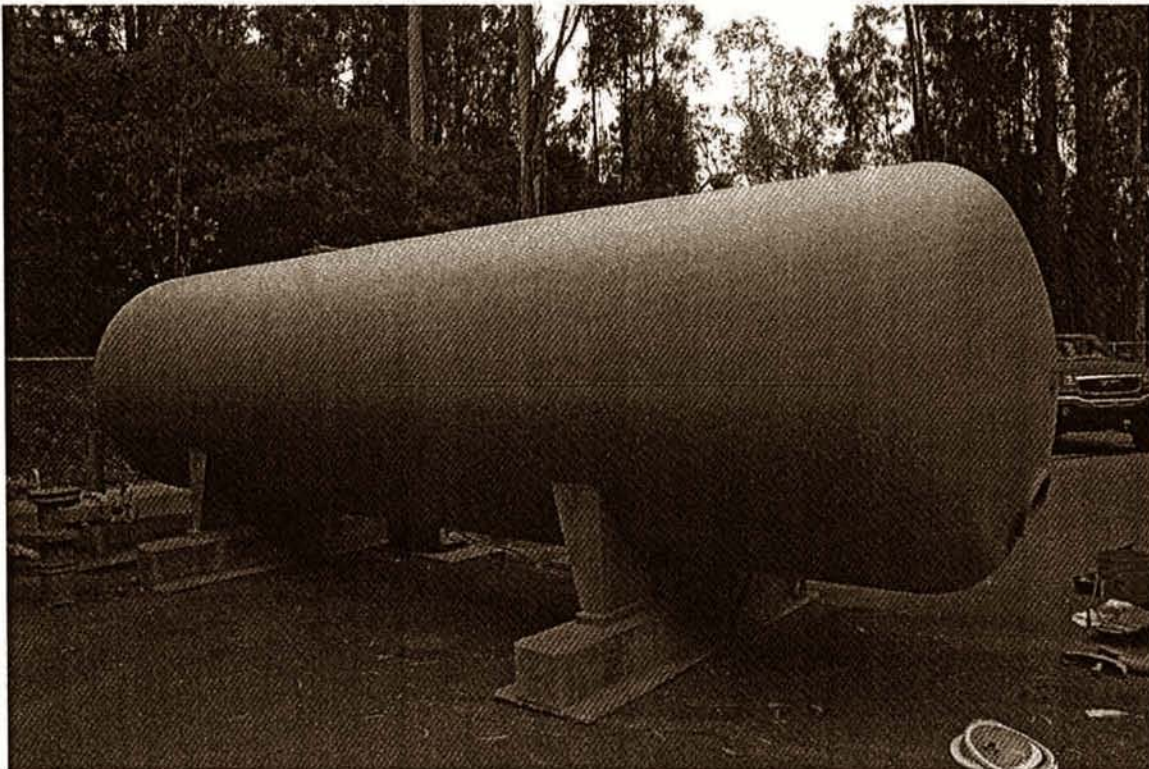
- 1) Overall the paint system is in good condition with minor oxidation and fading of the paint system. (Photos 1 through 9)
- 2) Minor corrosion is present on the irregular surfaces of the conduit and piping. (Photo 2 through 4)
- 3) Minor corrosion and staining is present at the edges of the identification plate. (Photo 6)

- 1) The overall condition of the paint system must be rated as good.
- 2) Moderate oxidation (chalking) and fading of finish is typical for an Alkyd paint system of this age.
- 3) Minor corrosion and staining at the edges of the identification plate (ID) is typically due to not properly preparing and painting the mounting plate surface before attaching the ID plate.

- 1 General view of the exterior of the Black Lake Hydro-Pneumatic Tank, illustrating oxidation and fading of the paint system.

- a. The paint system on the exterior surfaces is in overall good condition. If the District would like to remove the minor oxidation, pressure washing the surfaces can be accomplished to restore the gloss.

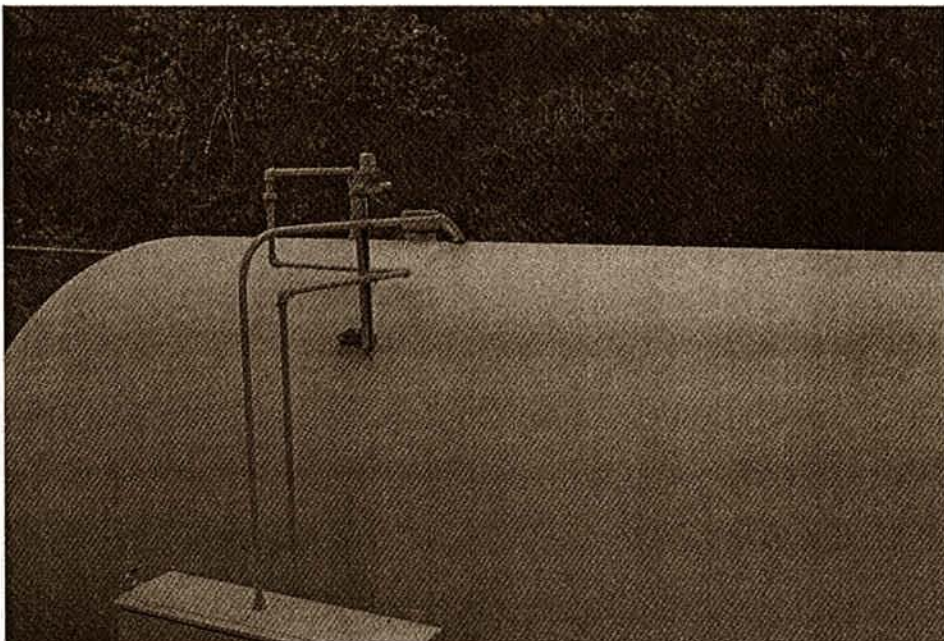
- 2 View of the tank and piping, illustrating random minor corrosion present at the irregular surfaces of the piping.

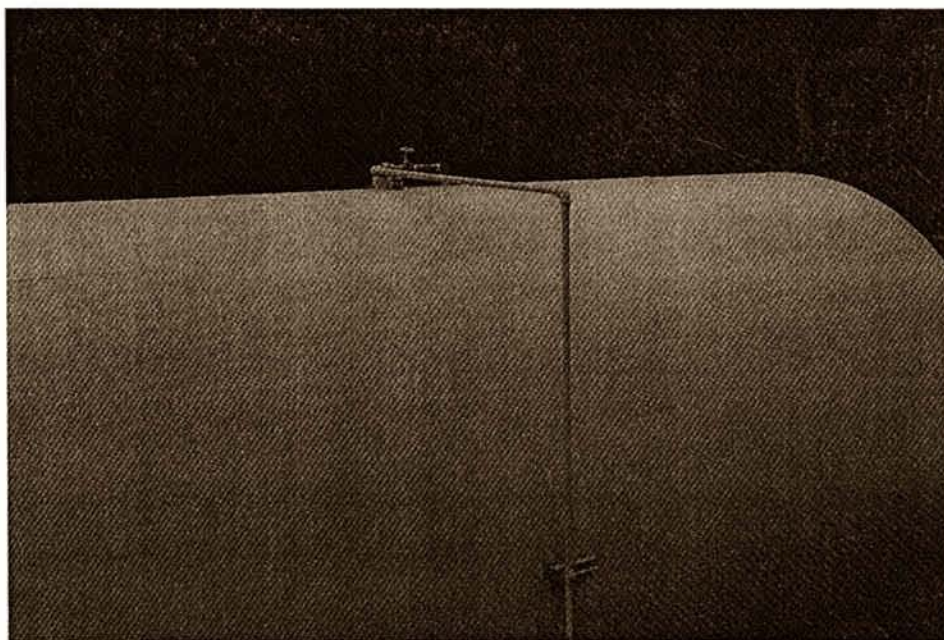
- 3 Same as Photo 2 except at a different location.

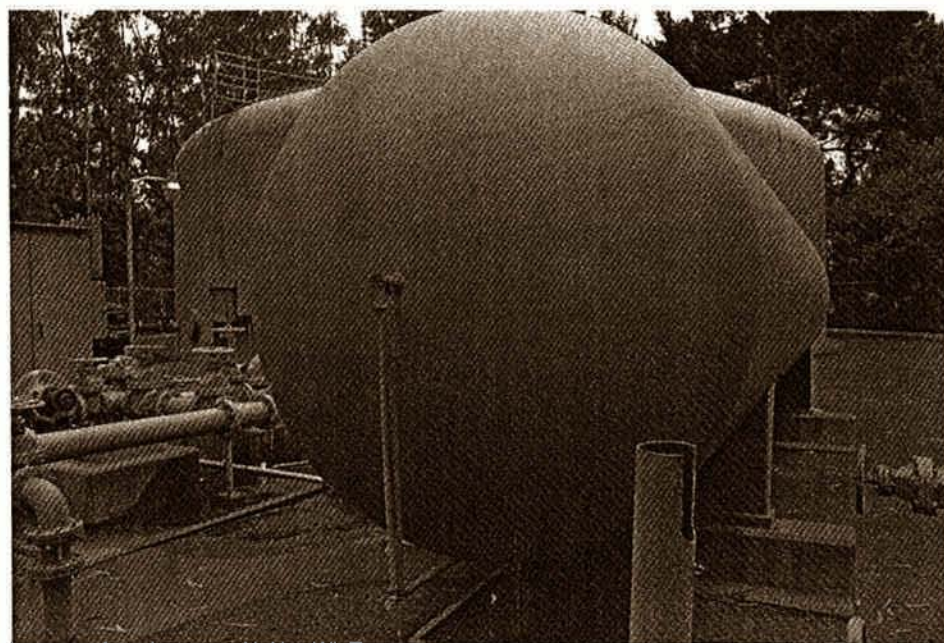
- 4 View of the end of the tank, illustrating minor oxidation and fading of the paint system.

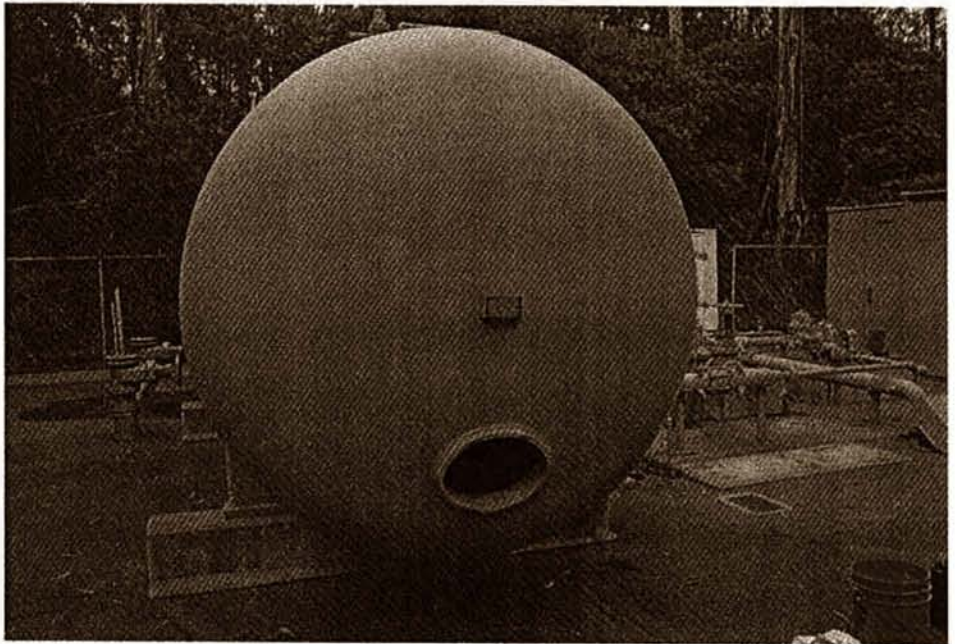
- 5 View of the end of the tank at the manhole, illustrating random minor corrosion at the circumference of the manhole and oxidation and fading of the paint system.

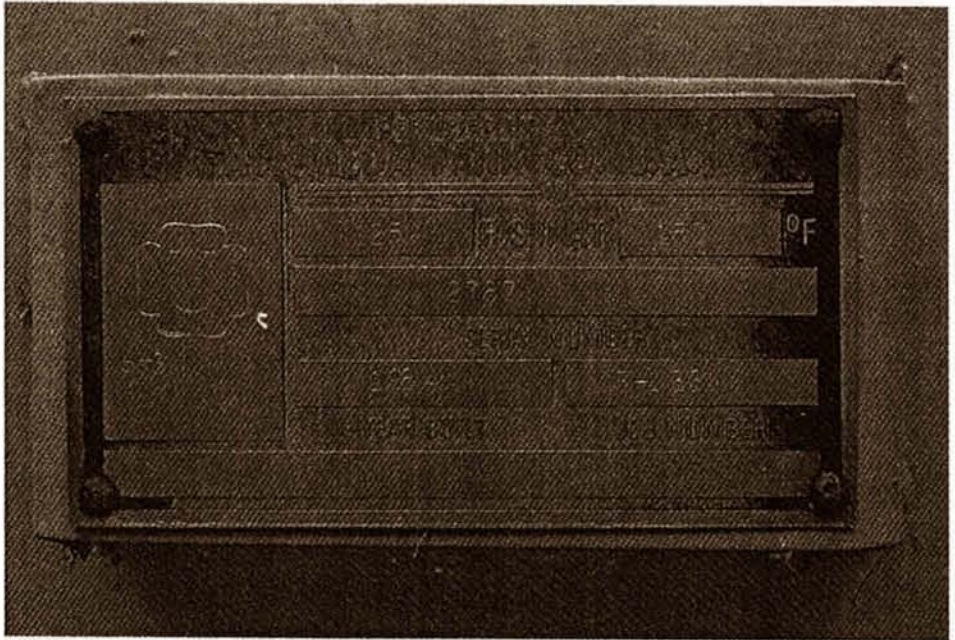
- 6 View of the identification (ID) plate, illustrating minor corrosion and staining at the rivets.

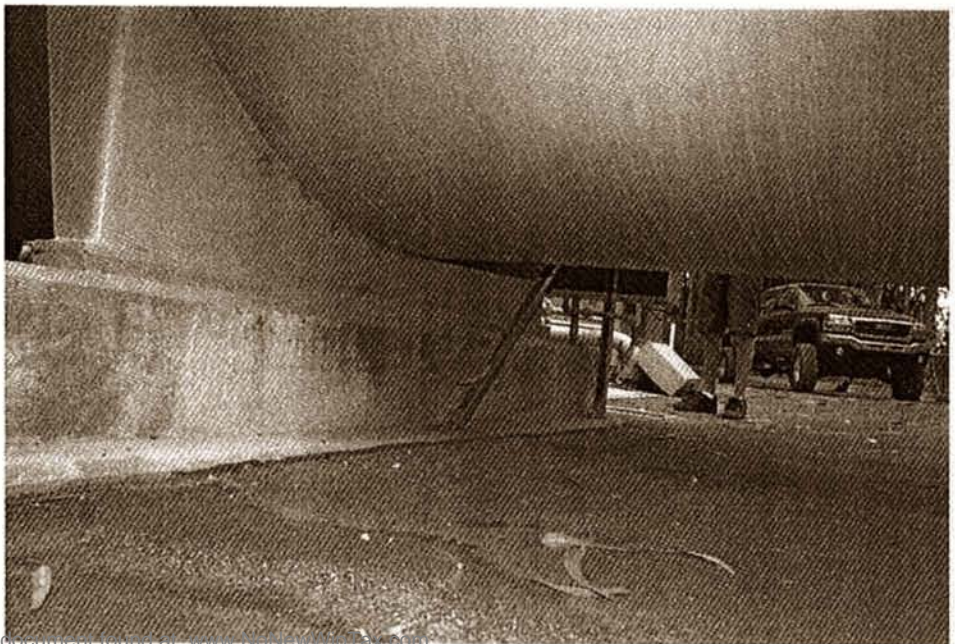
- 7 View of the underside of the tank, illustrating streaking of the paint and otherwise good condition of the paint system.

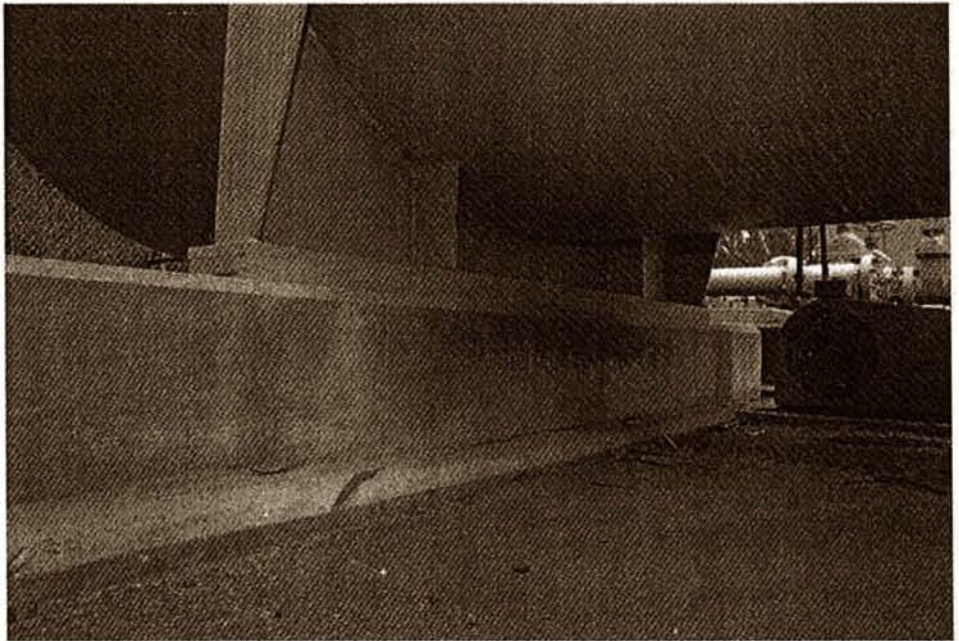
- 8 Same as Photo 7, except at a different location.

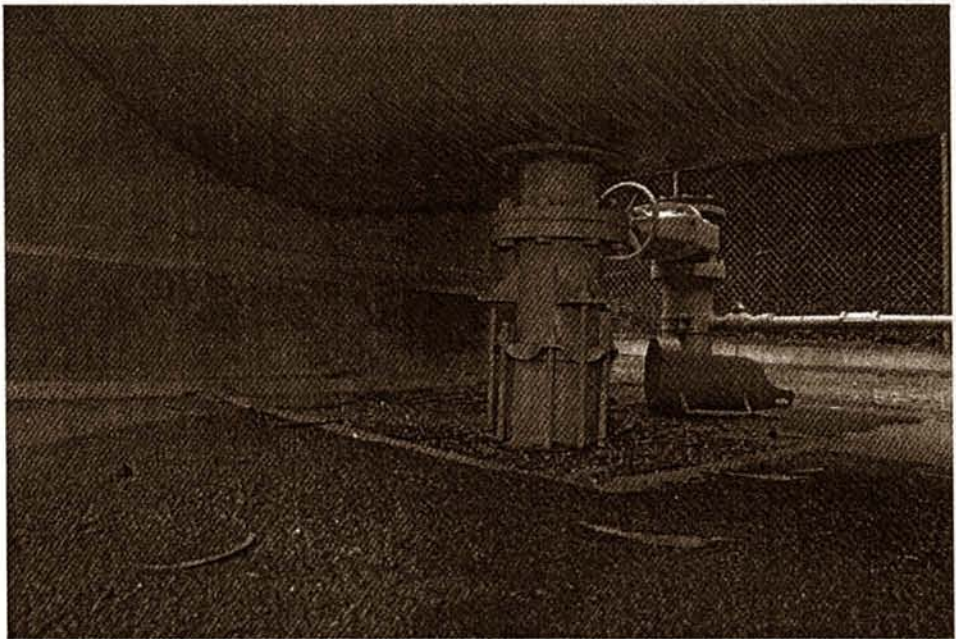
- 9 Same as Photos 7 and 8, except in a different location. Note good condition of the piping and flanges.

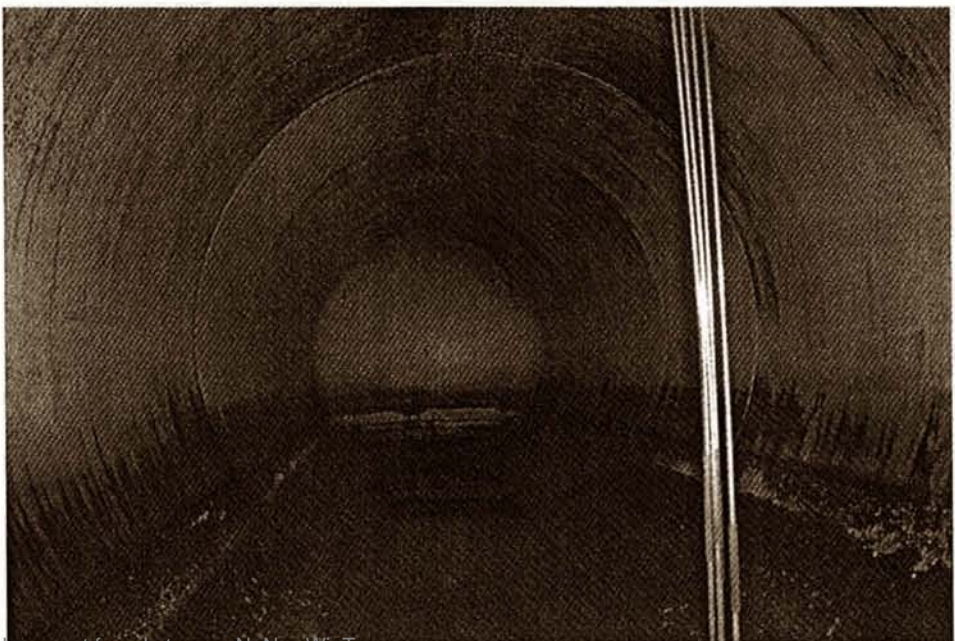
- 1) Overall the coating system on the interior surfaces is in poor condition with random areas of general corrosion, delamination and isolated areas of moderate to severe rust scale present. (Photos 10 through I-32)

- 2) Moderate general corrosion on the roof and upper portions of the shell appears to be due to the age of the coating system as existing epoxy coating system typically has a lifespan of approximately 20-25 years depending on the service conditions.

- 10 View of the interior of the tank, illustrating random general corrosion present on the interior surfaces and dark brown staining on the lower portion of the tank.

- a. The interior surfaces are in overall poor condition with random general and isolated corrosion present and isolated areas of etching and pitting of the substrate present. Due to the overall poor condition of the coating system, HAE recommends that the interior coating system be totally removed and replaced. All interior defective surfaces should be abrasively blast cleaned to Near White Metal (SSPC-SP10) and a three coat epoxy coating system be applied to a minimum thickness of 15 mils on all epoxy coated surfaces.

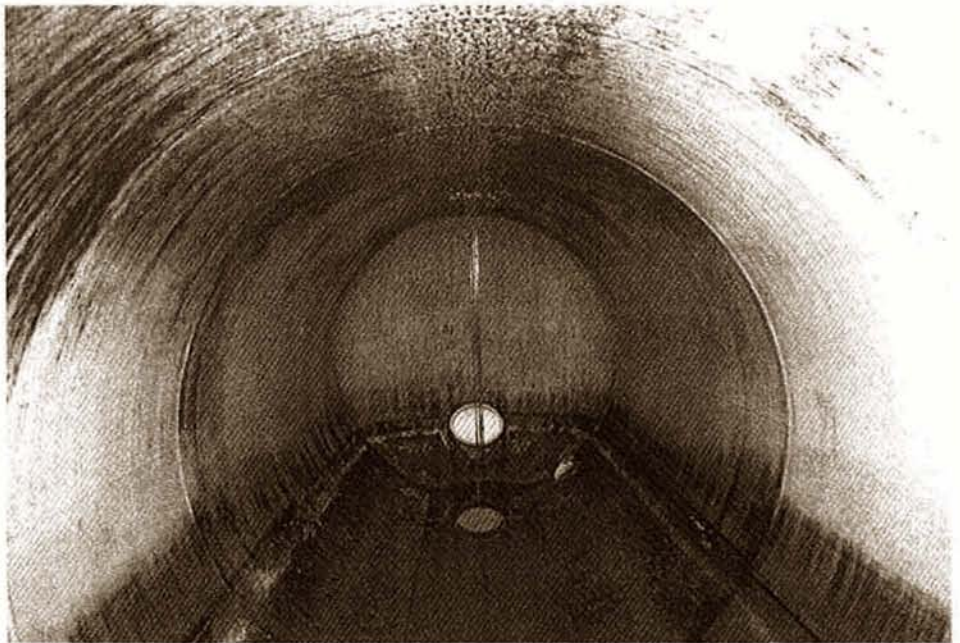
- 11 Same as Photo 10, except from the opposite end of the tank.

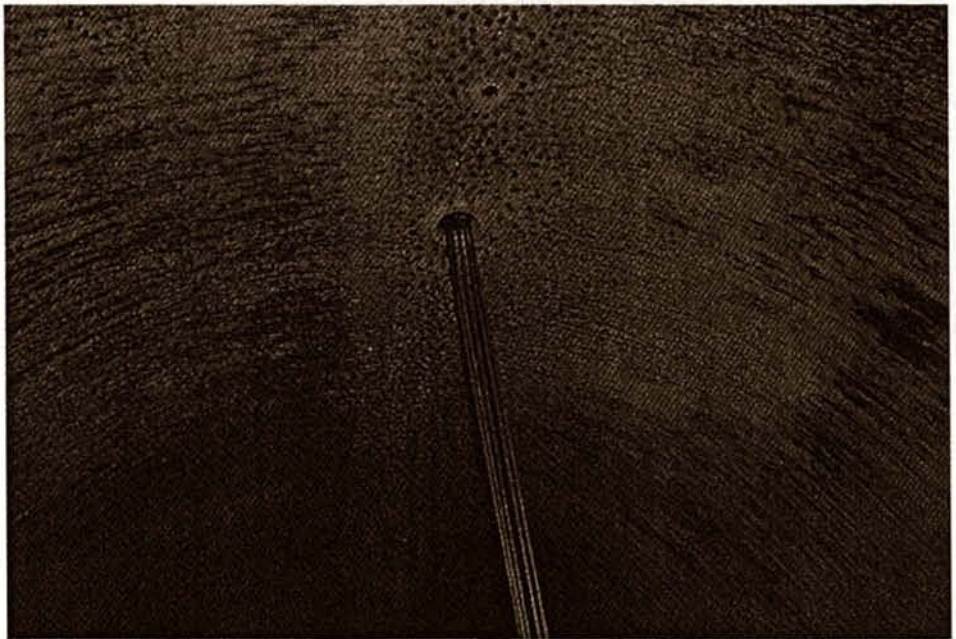
- 12 Close-up view of the upper portion of the tank, illustrating cracked and blistering coating with corrosion present.

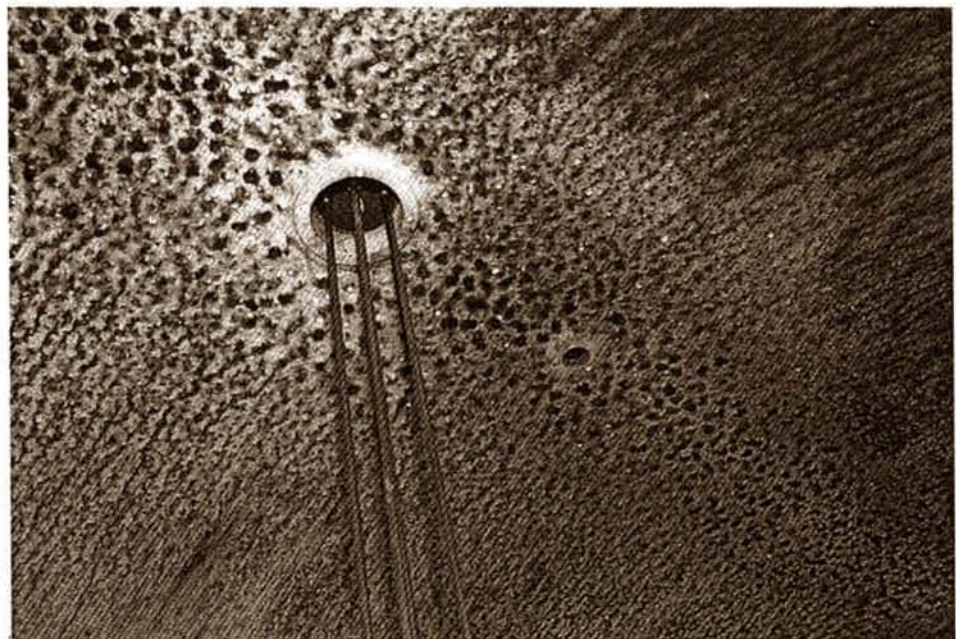
- 13 Same as Photo 12, except at a different location. Note good condition of the two penetrations.

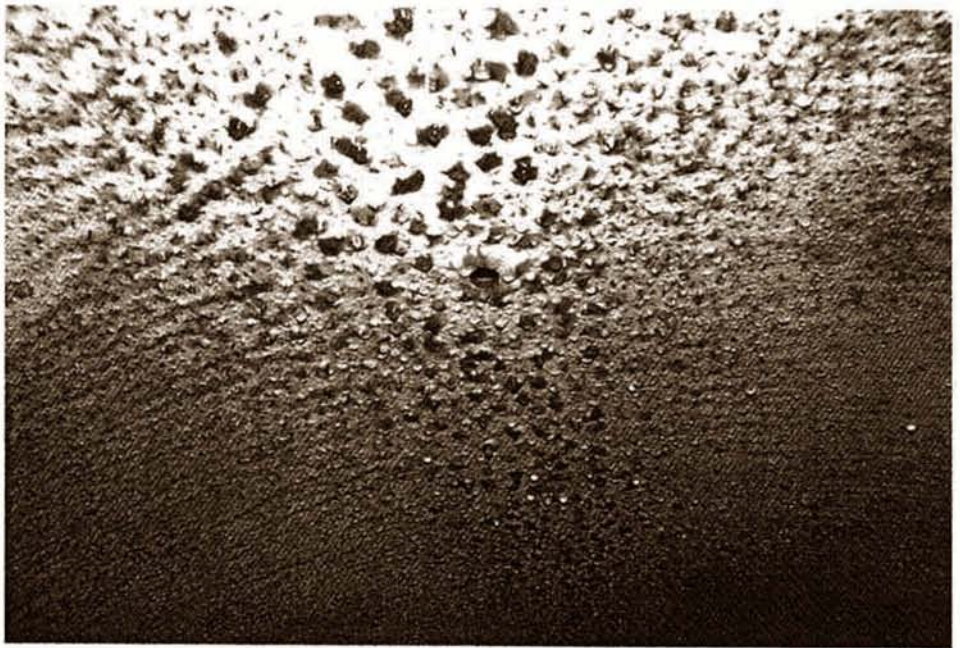
- 14 Close-up view of the upper portion of the tank, illustrating cracked and blistering coating with corrosion present.

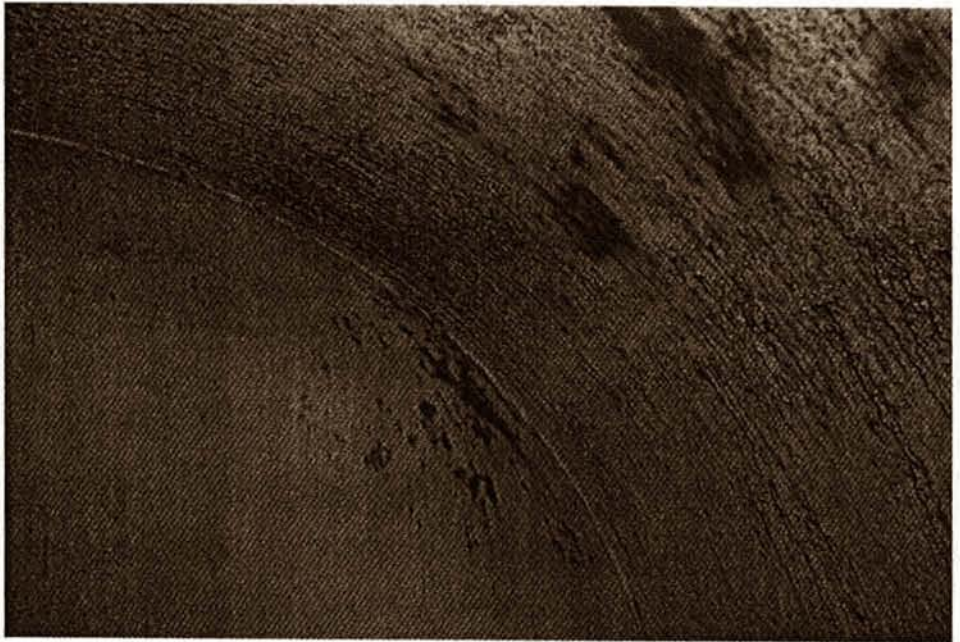
- 15 View of the side to end transition, illustrating general corrosion and staining on all surfaces.

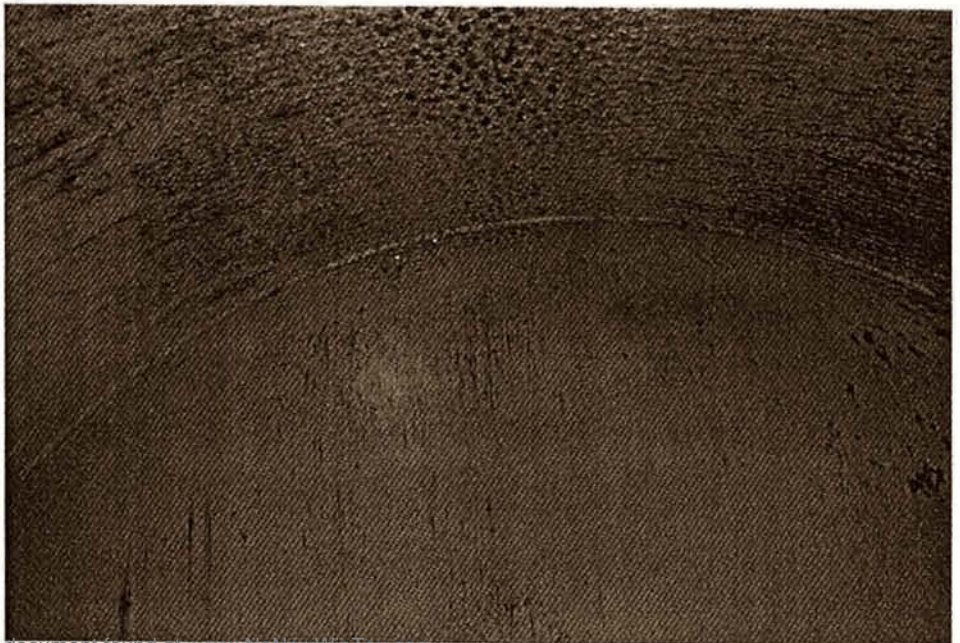
- 16 Same as Photo 15, except at a different location.

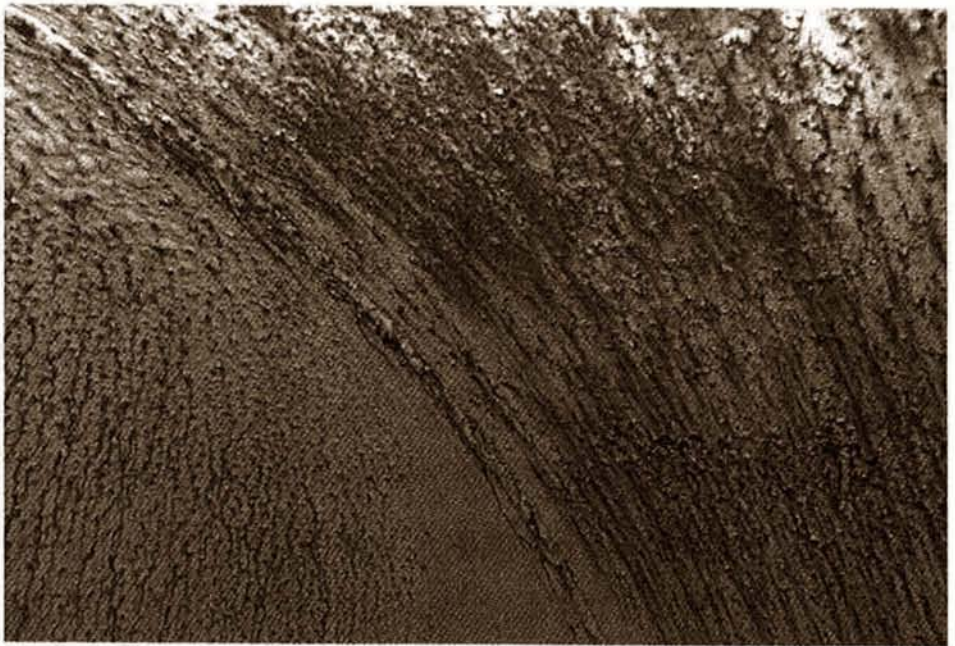
- 2) Moderate general corrosion is present on the roof and upper portions of the shell. (Photos 10 through 16)
- 3) Random areas of blistered coating with corrosion are present with isolated areas of minor etching and pitting of the substrate present. (Photos 17 and 18)

- 17 Close-up view of the tank, illustrating severe blistering and cracking of the coating with corrosion present.

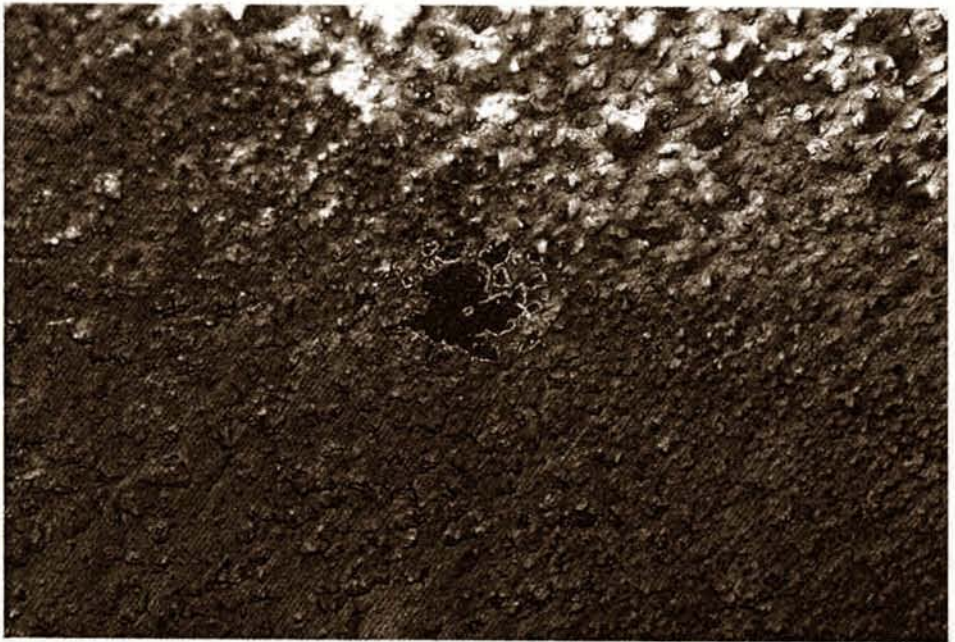
- 18 Close-up view of the tank, illustrating an area of bare steel with minor pitting of the substrate present.

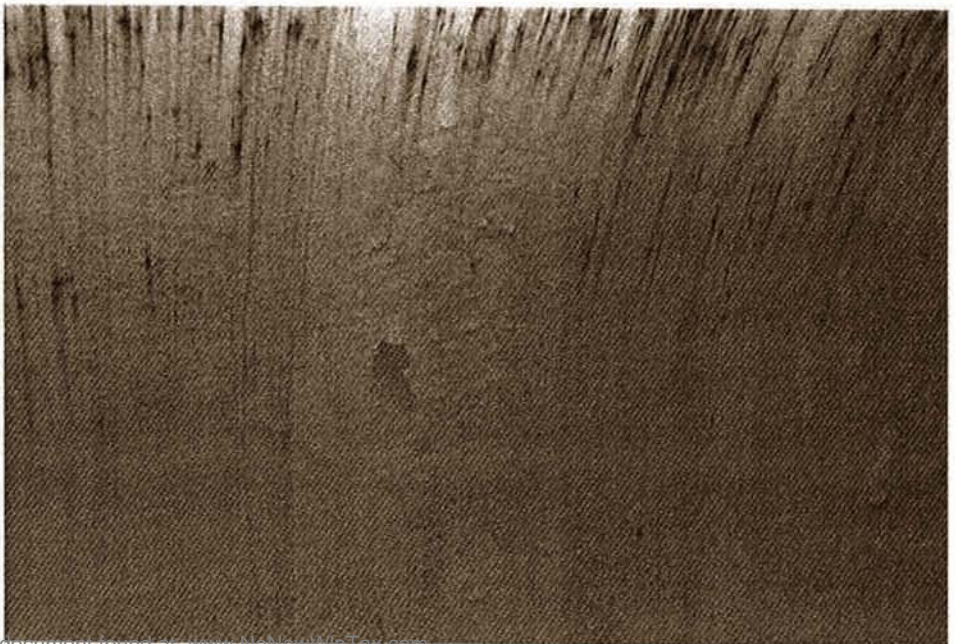
- 4) Random areas of delamination are present. (Photos 19 through 21)
- 5) An isolated spot of severe corrosion was noted with minor pitting of approximately 1/32". (Photos 22 and 23)

- 3) Random locations of delamination appear to be due to patchwork accomplished after the original coating system was applied.
- 4) Isolated areas of severe corrosion, etching and pitting of the substrate are due to the overall deterioration of the coating system and the lack of maintenance where severe deterioration has occurred.

- 19 View of the side of the tank, illustrating blistering and delamination of the coating system with corrosion present.

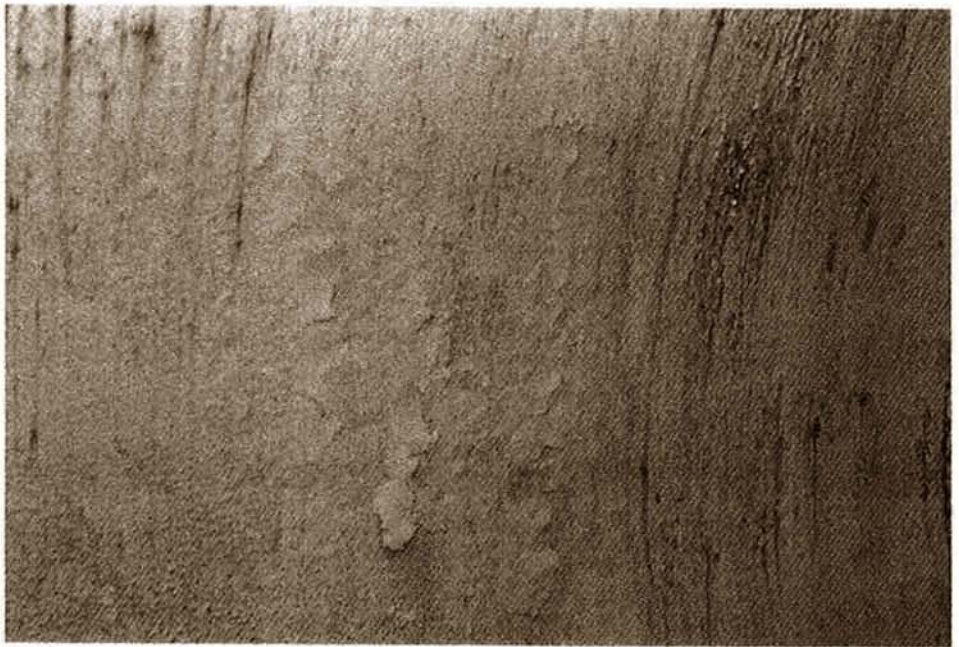
20 Same as Photo 19,
except at a different
location.

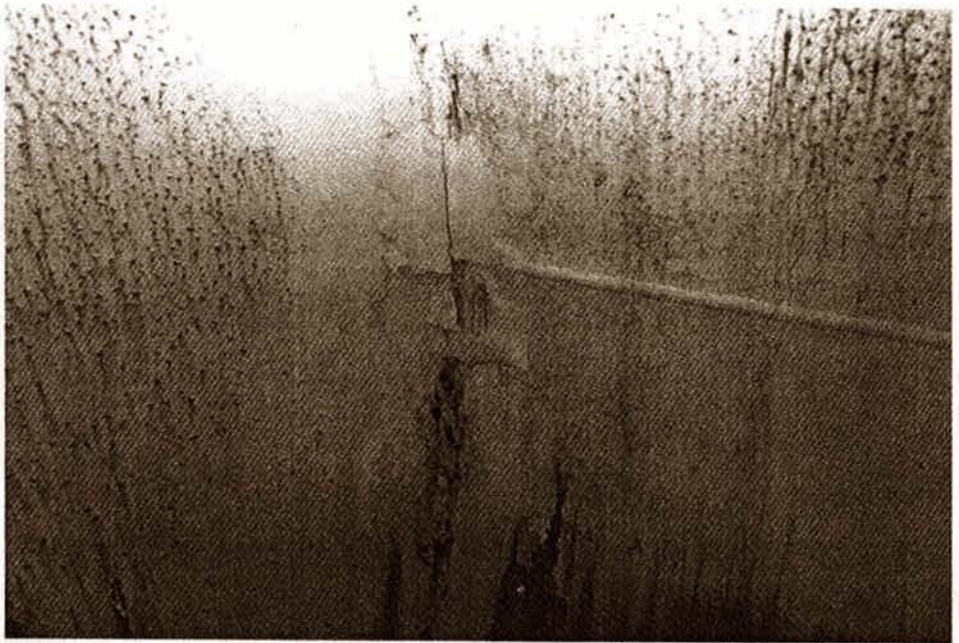
21 Same as Photos 19 and
20, illustrating
delaminating and
blistered coating with
corrosion present.

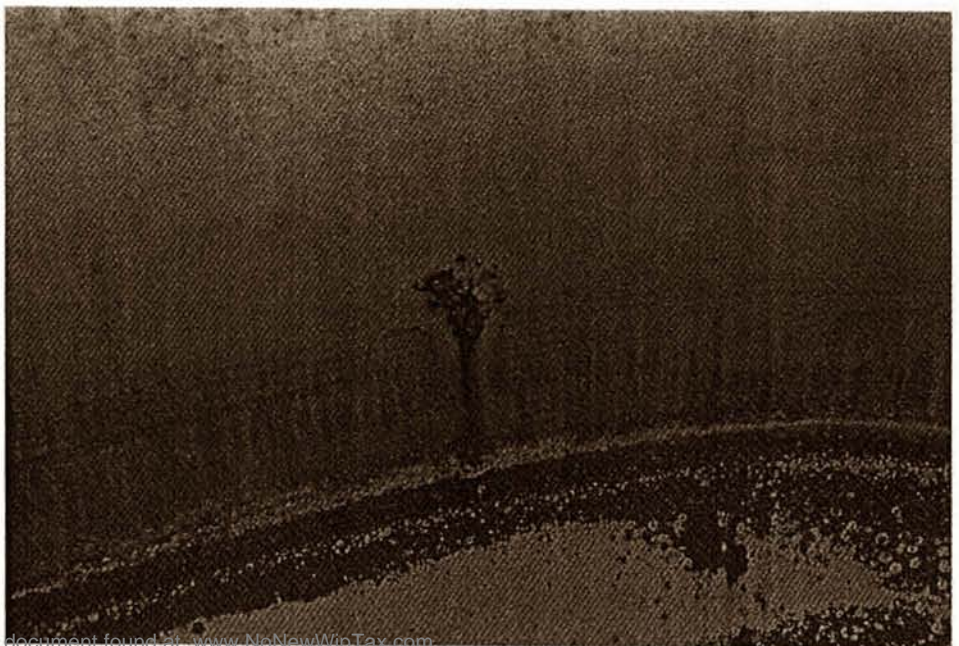
22 Close-up view of the
side, illustrating
blistering of the coating
and an isolated area of
severe corrosion
present.

- 1) After abrasive blasting the interior surfaces the metal loss at areas of severe corrosion should be examined to determine if any minor repairs should be accomplished.

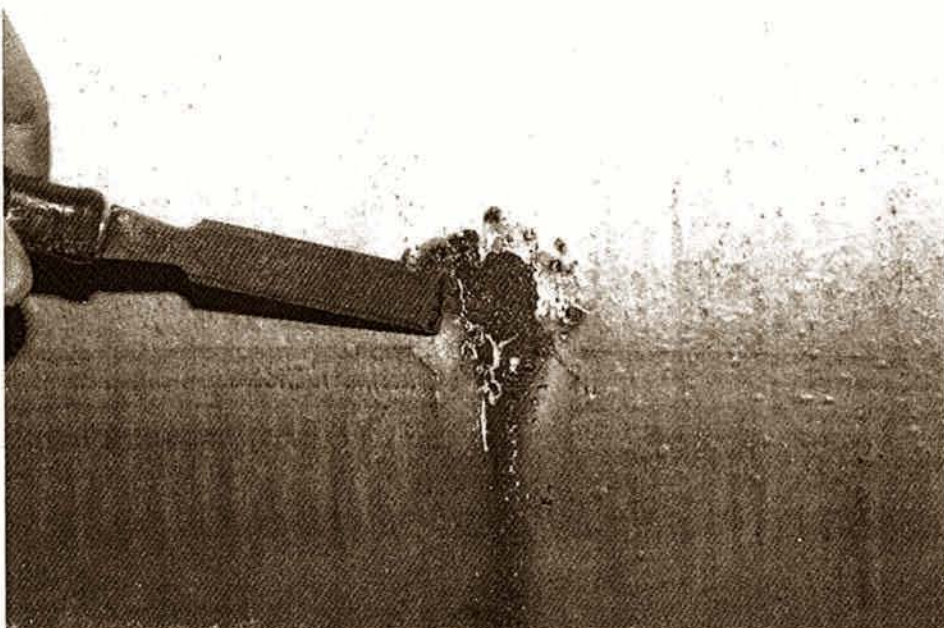
- 23 Same as Photo 22, except the corrosion was removed to illustrate minor pitting of the substrate.

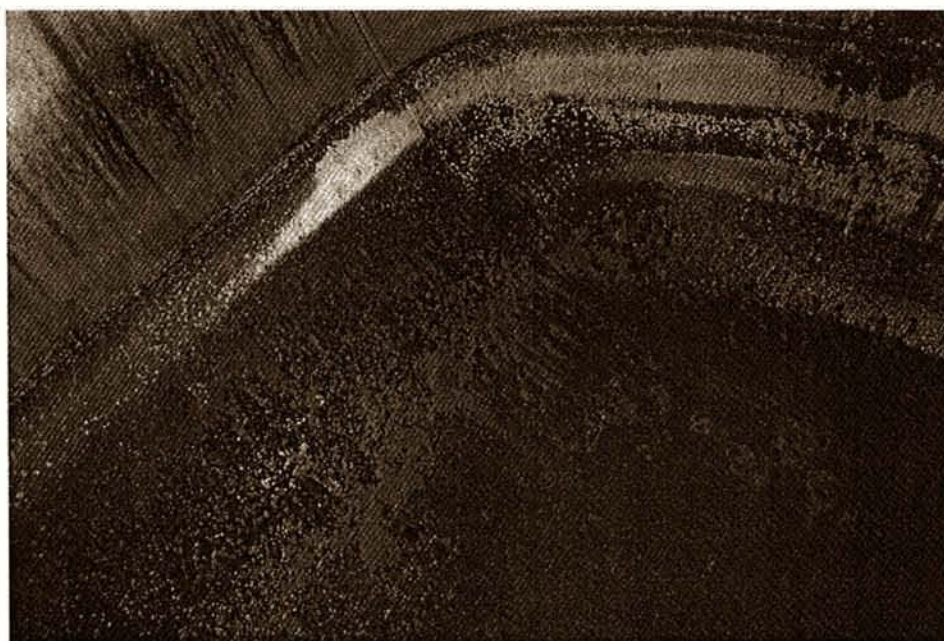
- 6) Random rust tubercles are present on the lower surfaces of the pressure vessel. (Photos 24 through 27 and 29 through 32)
- 7) Moderate corrosion is present on the welds in random locations. (Photo 28)

- 24 View of the bottom portion of the tank, illustrating random blistering of the coating with corrosion and dark brown staining present.

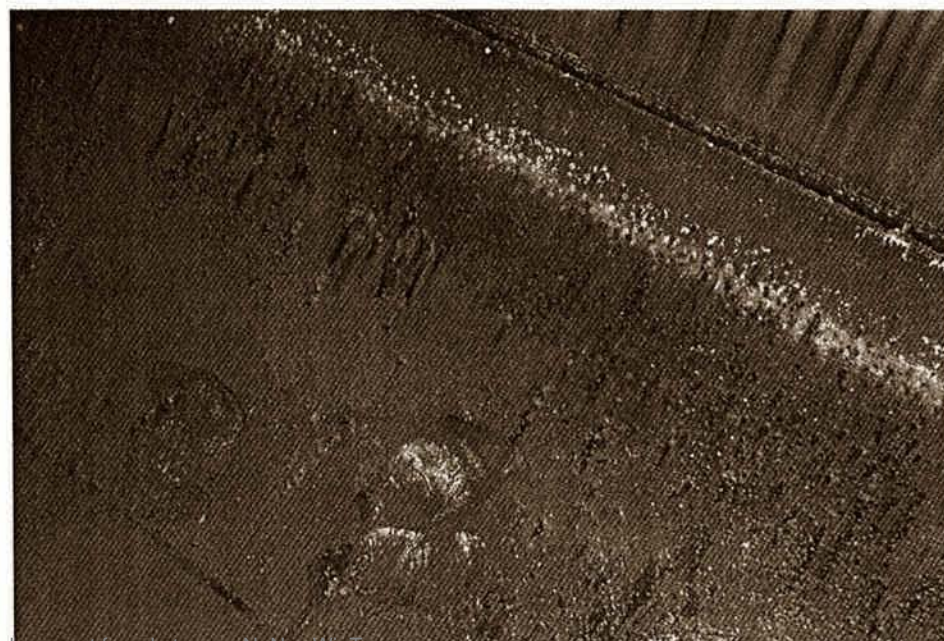
- 25 Same as Photo 24, except a closer view of the bottom. Note numerous rust tubercles present.

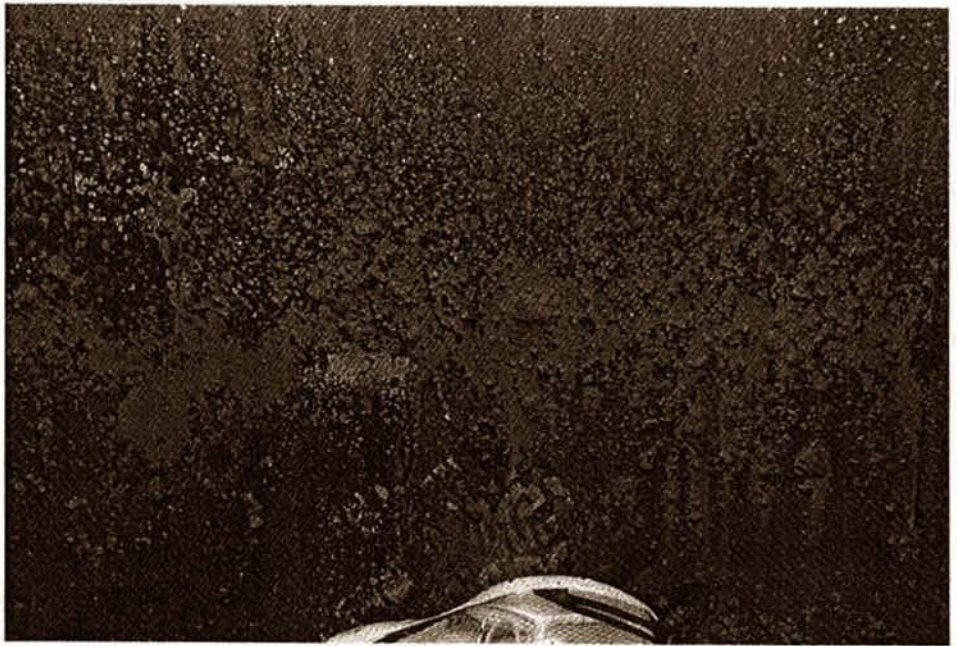
- 26 Close-up view of the bottom, illustrating blistering, staining and random tubercles present.

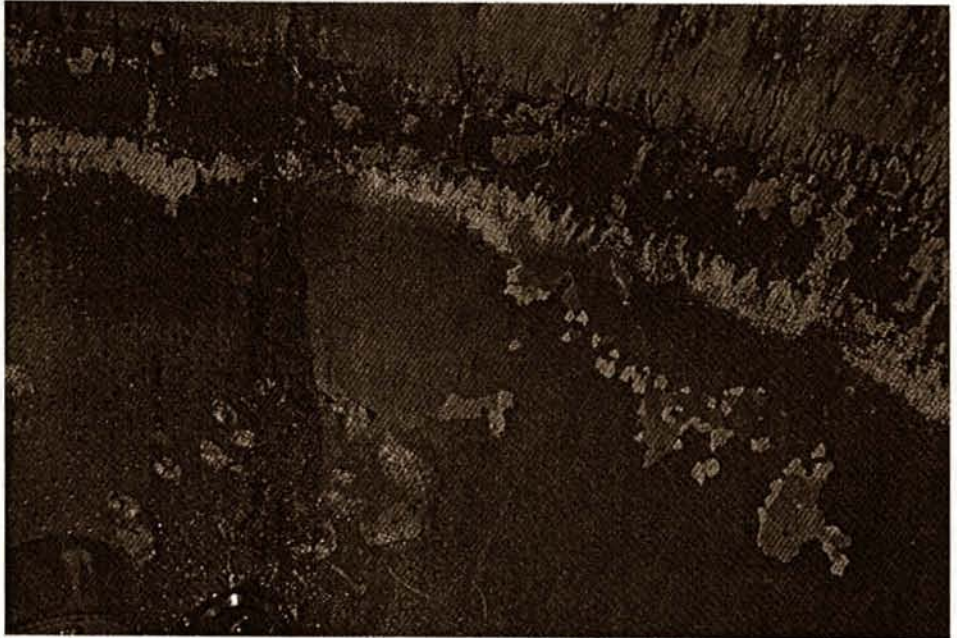
- 27 View of the bottom portion of the tank, illustrating delamination of the coating and severe staining present.

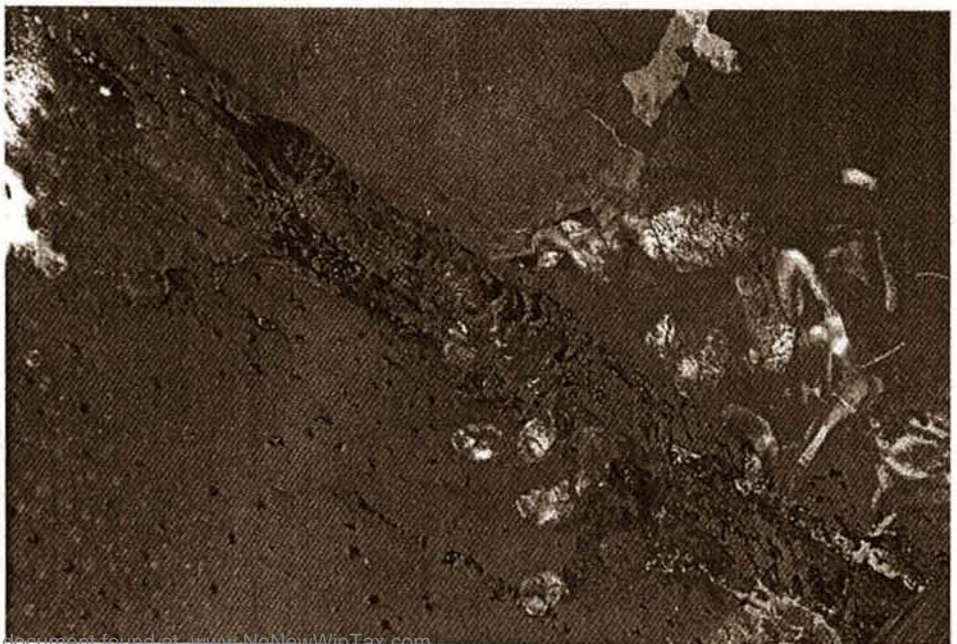
- 5) Moderate to severe corrosion at the welds is due to a combination of the age of the coating system and possibly not brush applying the coating to the welds to ensure proper mil thickness on these irregular surfaces.

- 28 View of the bottom of the tank, illustrating moderate to severe corrosion along a weld seam.

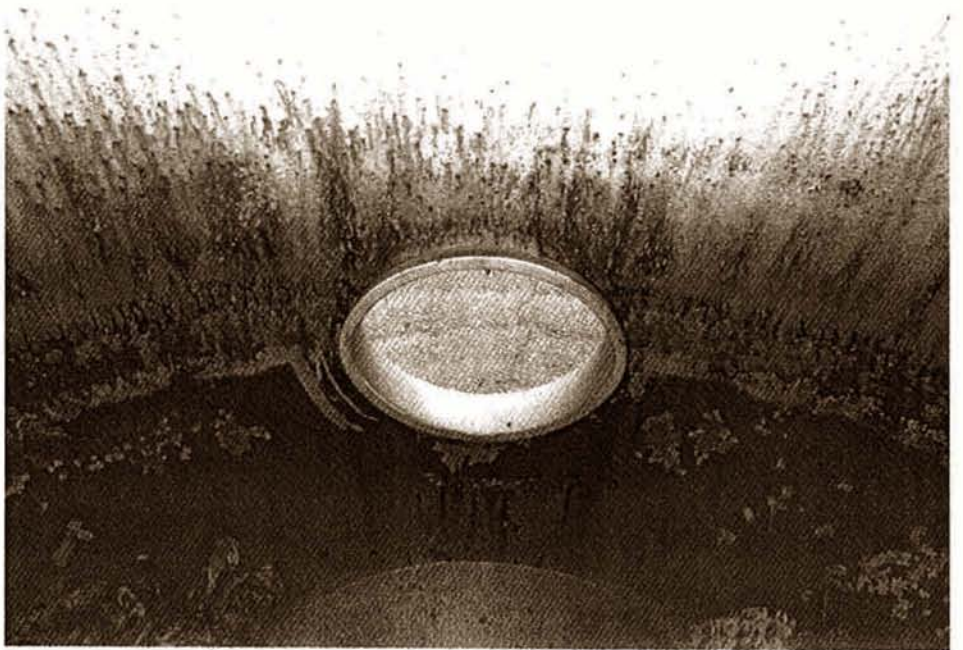
- 29 View of the manhole, illustrating random blistering, delamination and staining of the coating system on adjacent surfaces.

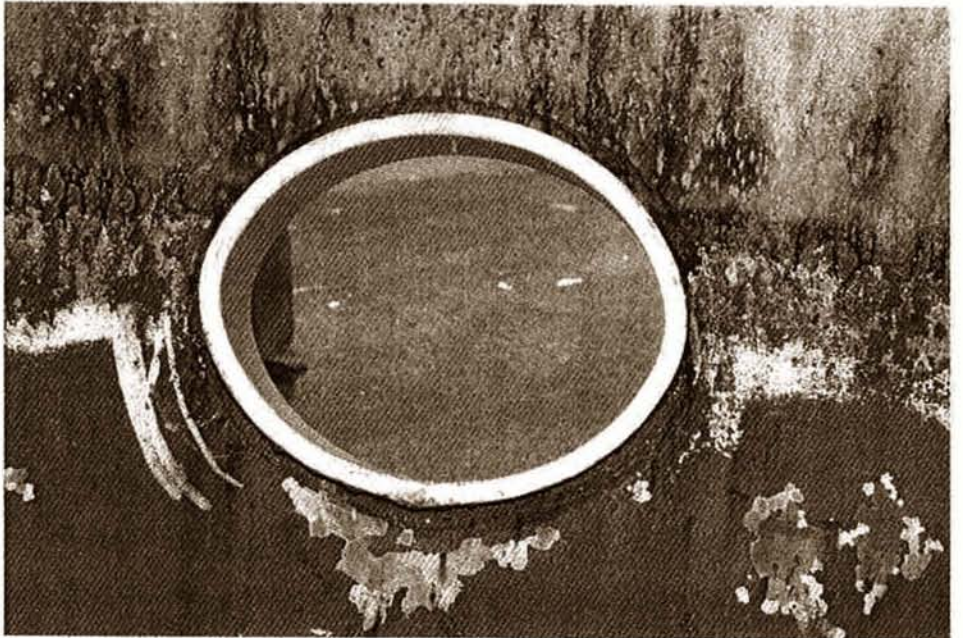
- 30 Same as Photo 29, except at a different angle.

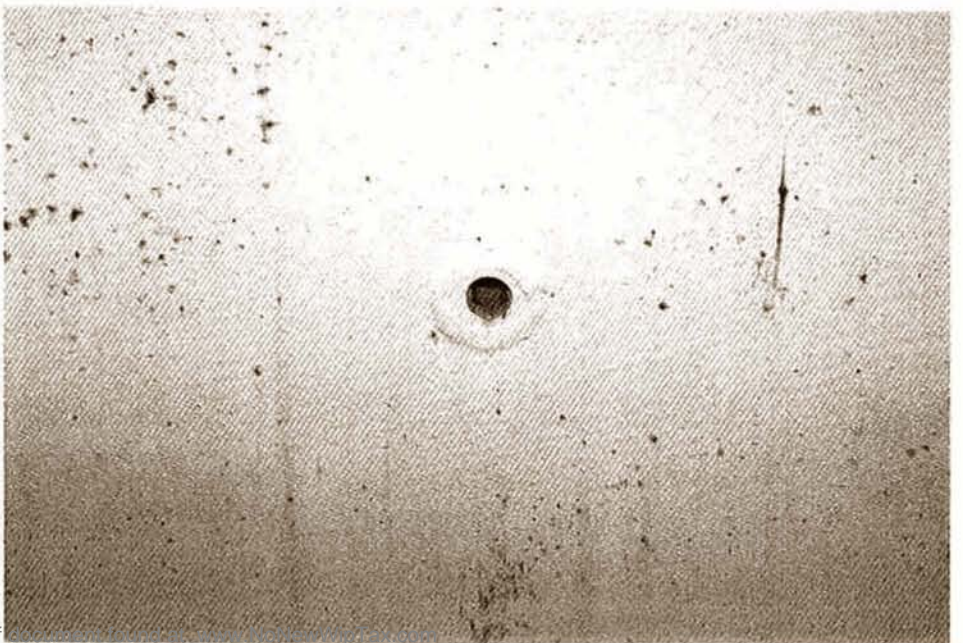
- 31 View of a penetration, illustrating blistering and cracking of the coating on the adjacent surfaces with corrosion present.

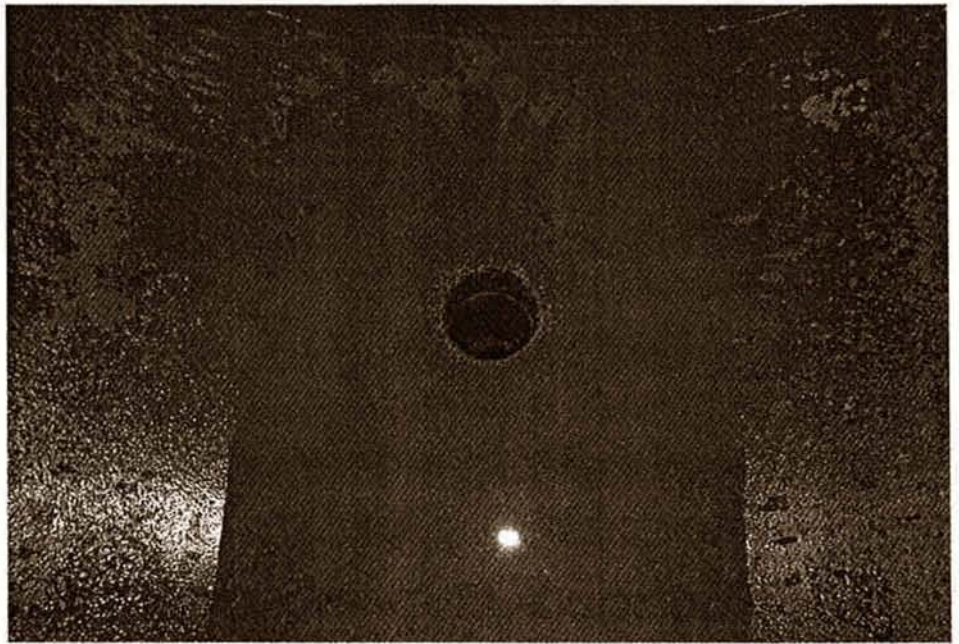
32

- 8) Random rust tubercles are present at the inner circumference of the outlet and on adjacent surfaces. (Photo 32)

View of the outlet,
illustrating random
corrosion present on
the interior
circumference of the
penetration.
