## MANAGER'S REPORT

Standing report to your Honorable Board -- Period covered by this report August 15, 2007 through September 5, 2007

# ENGINEER'S RÉPORT

PROJECT:	Inspection of a Welded Steel Water Storage Tank
STRUCTURE:	400,000 Gallon Welded Steel Water Storage Tank (Black Lake Water Storage Tank)
OWNER:	Nipomo Community Services District
LOCATION:	Nipomo, California
INSPECTION BY:	Andre Harper
REPORT DATE:	July 2007

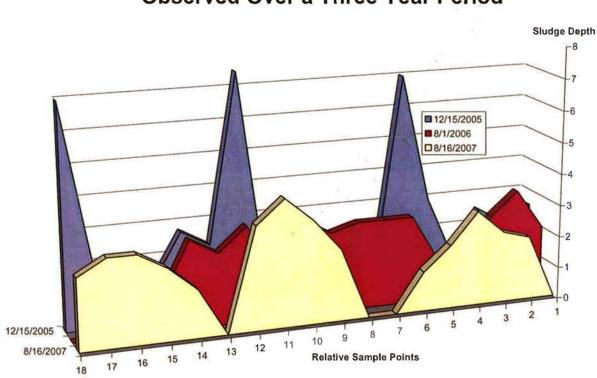
# Black Lake Pond # 1 Sludge Blanket Profile Observed Over a Three Year Period

Changing aerator positions at Black Lake Pond # 1 has helped remove over one foot of sludge resulting in estimated sludge removal savings of about \$20,000. Our recommendation is to continue your practice of repositioning aerators at Black Lake once each quarter.

Sludge accumulated at the influent end of Black Lake Pond #1 is significantly reduced. As aerators are moved to the effluent end (not too close to the effluent pipe), sludge will begin to be removed from here as well.

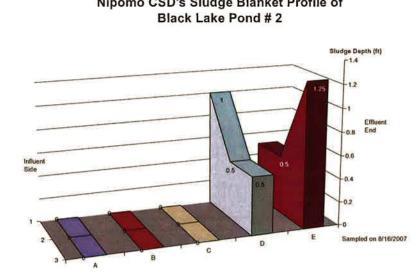
Nipomo CSD's Sludge Blanket Profile of

Pond # 2 was de-sludged and minimal sludge is present as can be seen in the figure below:

The de-sludging of the Black Lake Ponds, with aerator relocation has resulted in the pond system yielding good effluent quality.

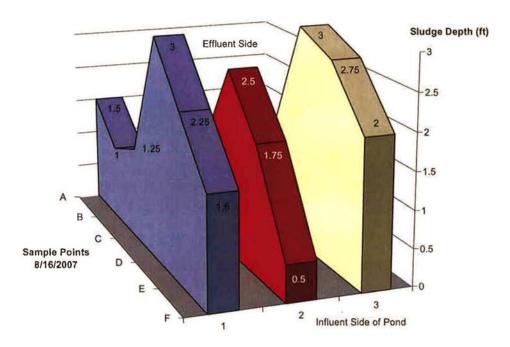
# Nipomo CSD's Sludge Blanket Profile for the Southland # 3 Pond

Even with Primary Aeration Basin # 1 out of service for sludge removal, the remaining ponds running in series are producing a good quality effluent. The splashing aerators and mixers are doing their job at transferring oxygen to the system.

De-sludging Secondary Aeration Basin # 1 will further improve effluent quality and make nitrogen removal easier. It is widely accepted that sludge accumulation over 18 inches leads to algae bloom and BOD violations. Accumulated sludge is also a "sink" for accumulated nitrogen. Remove the sludge and remove the BOD, algae, and nitrogen in the effluent.

My recommendation is to give serious consideration to adding a bar screen and grit and trash removal system to your headworks. I was distressed to see all the floating plastic and trash in the system as I sludge judged your lagoons. This trash leads to faster sludge accumulation leading to volume reduction. Rags and fabrics also interfere with the operation of aeration equipment.
