E. AESTHETICS

F. CULTURAL RESOURCES

NCSD Waterline Intertie EIR

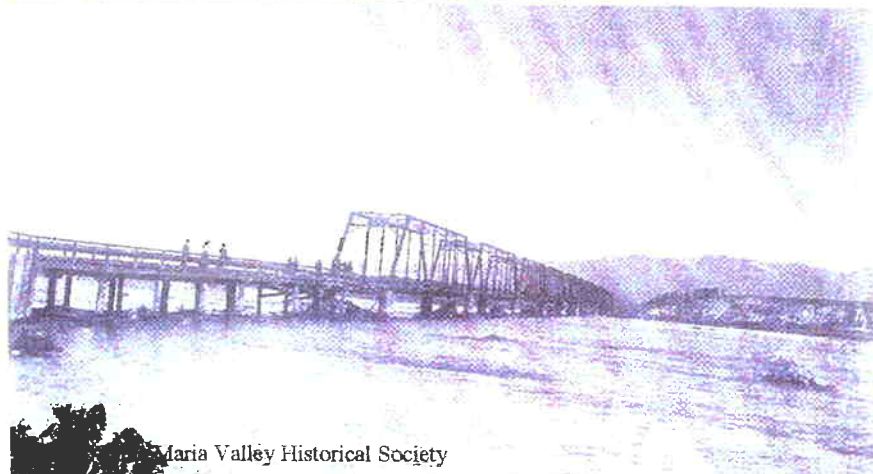
Original highway bridge during flood (unknown year) from Santa Maria bank (NCSD study area under water).

Major improvements to the original paved highway made by the State included construction of a concrete girder bridge at the Santa Maria River crossing in 1926 on the same alignment as the original bridge, in 1929-1930 when the road was upgraded with wider lanes and shoulders and repaving in 1938. Surveyors in 1937 first explored the Solomon Grade route used by the current Highway 101 and Santa Maria River crossing which was constructed in the mid to late fifties.

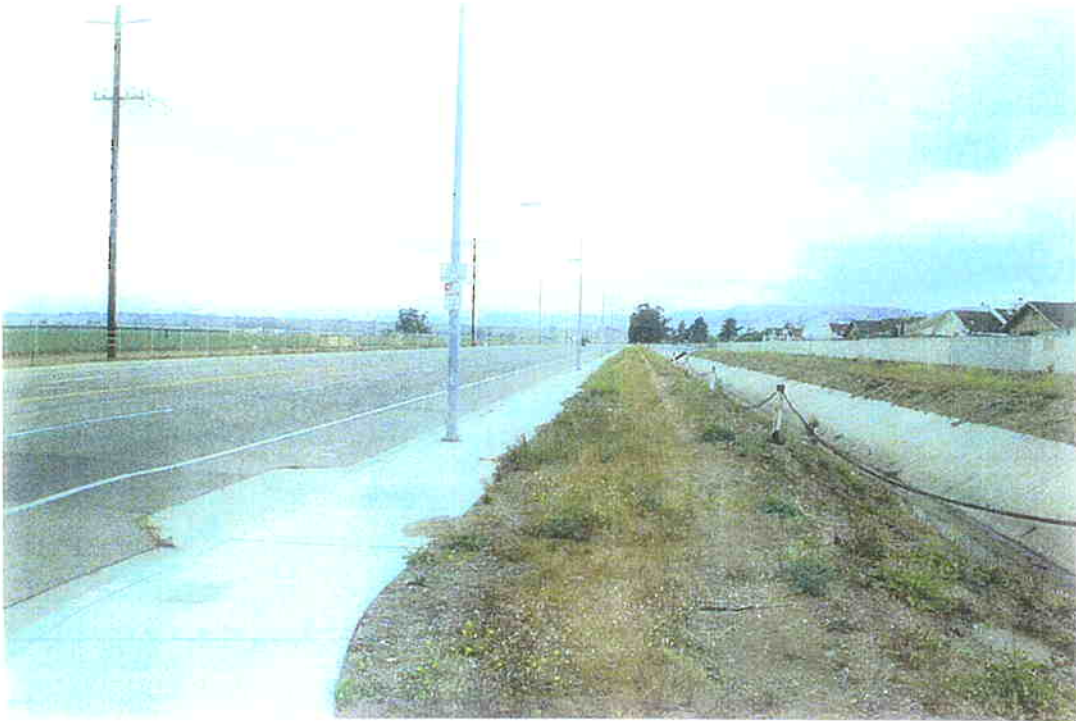
Photo 1: Blosser Road near West Taylor Street
along Pipeline Route

This section of the pipeline corridor is approximately 4,000 feet long and is located between West Taylor Street on the south and the Santa Maria River levee. Pavement, sidewalks and a deep concrete drainage ditch are on the east side of Blosser Road and agricultural fields are on the west side (see Figure 28A, Survey Location Site Photographs, Photos 1 and 2).

Native soils were a loose sandy loam with various sized gravels which indicate a very high alluvial deposition. This confirms the floods in the area. Although modern stream flows are contained in levees built between 1957 and 1959 for the Santa Maria Flood Control project, prehistoric and historic floods inundated the entire Santa Maria Valley plain as far south as Battles Road. No cultural materials were observed in this section.

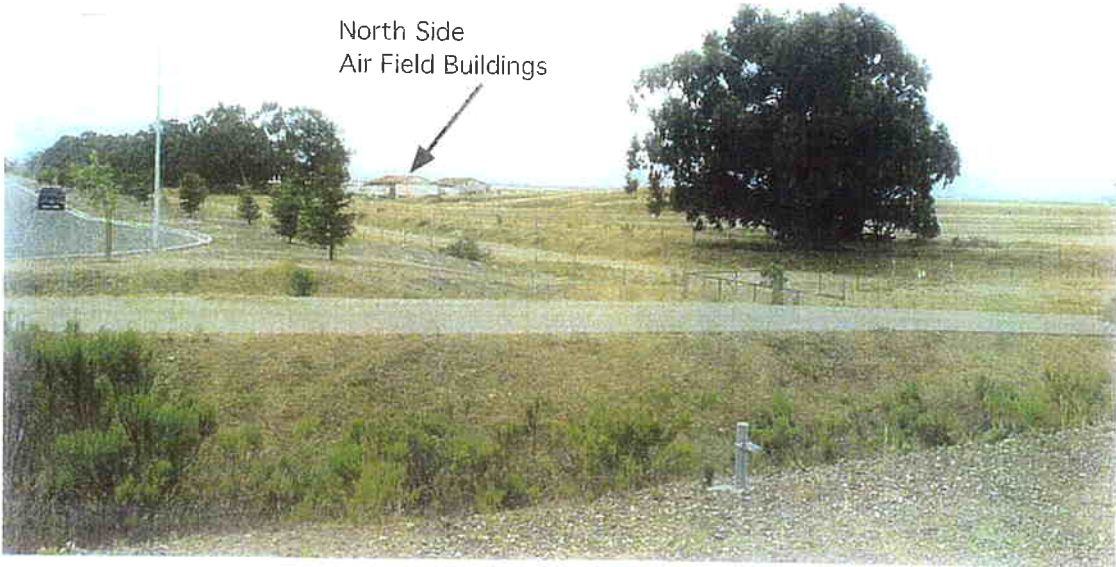
Photo 3: Blosser Road at Atlantic Street
Pump Station No. 1, Site 1

This area is located west of Blosser Road and south of the river levee. It consists of flat alluvial deposits and grades to the south into agricultural fields. South of the levee fence is some evidence of the North Side Air Field. Its single runway is about 3,500 feet long by 30 feet wide and was probably used for small aircraft or for an emergency landing field. Currently thin layers of asphalt and oil are visible along the airfield runway. The building and runway are south and outside any area proposed for direct impacts (see Figure 28B, Survey Location Site Photographs, Photo 3).

This survey area did not contain any prehistoric or significant historic cultural materials. Based on the geomorphological analysis and historic archival research, the entire Pump Station 1, Site 1 is within areas that prehistorically would have been seasonally flooded. No cultural materials were observed at this location.

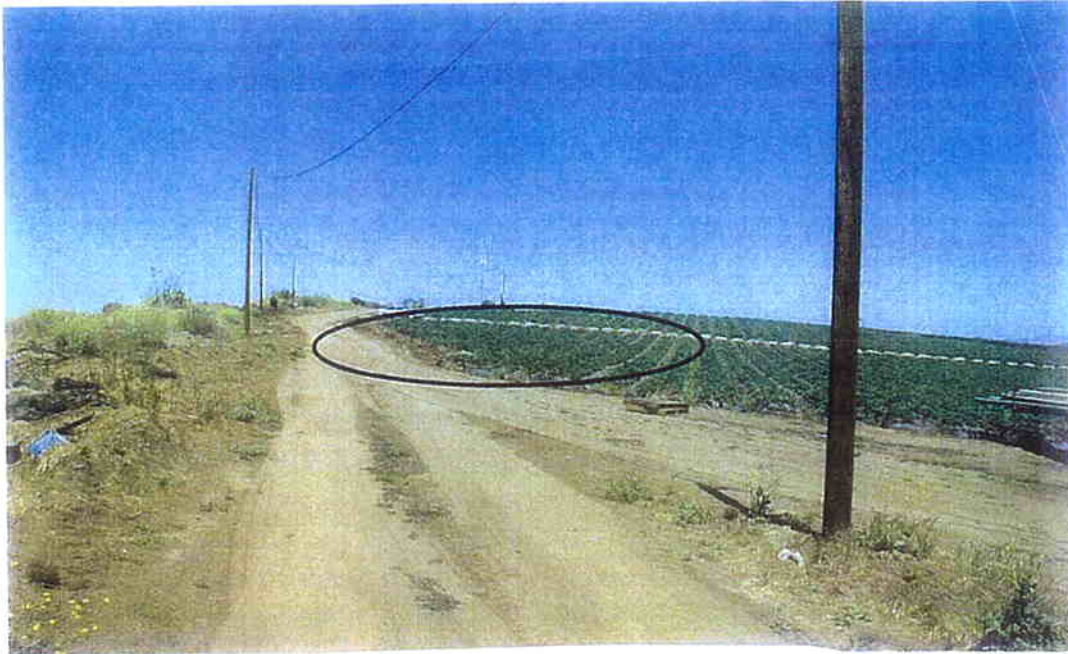
Photo 5: Edge of Nipomo Mesa looking North
Water Storage Tank Site 3 and
HDD Laydown Area

This proposed pump station/water storage tank site is also the location of the HDD Laydown area (see Figure 28C, Survey Location Site Photographs, Photo 6). An area approximately 300 feet by 300 feet was examined. It is located on the north terrace edge of the Nipomo Mesa overlooking the Santa Maria River. Currently the area is planted in strawberries. No cultural materials were observed during the current examination of this area.

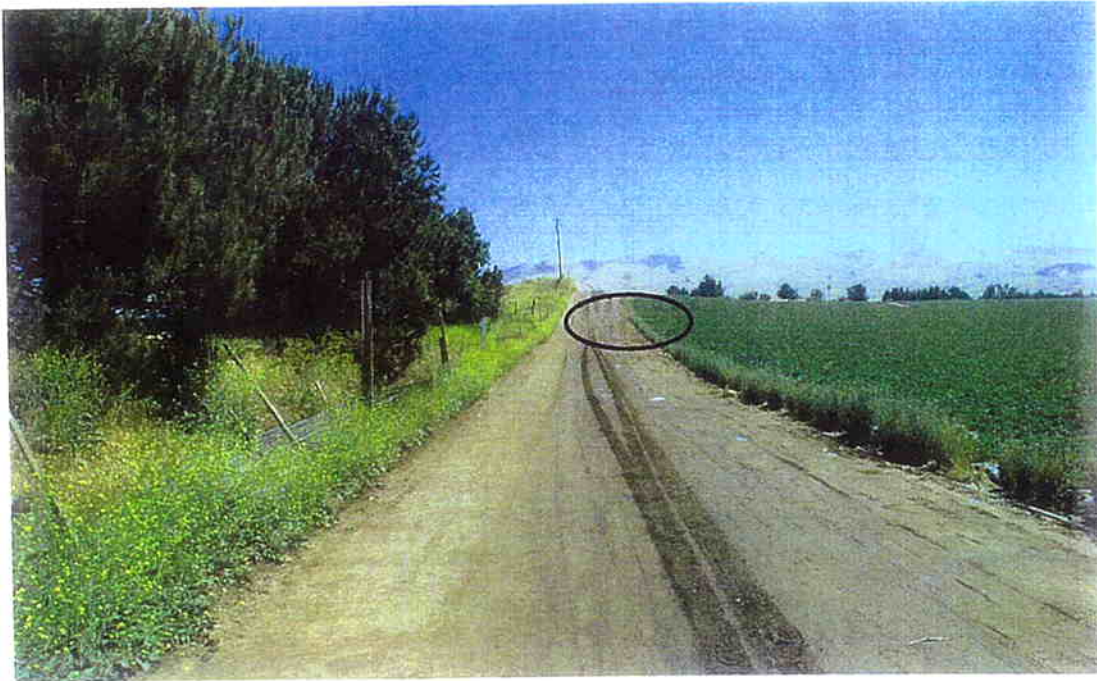
Photo 6: Nipomo Mesa looking East toward Orchard Avenue
Water Storage Tank Site 1

Located just south of Joshua Street and Orchard Road, this pump station/water storage tank location was originally surveyed in 2005 (see Figure 28C, Survey Location Site Photographs, Photo 5). The area included a dirt access road adjacent to agricultural fields. No prehistoric or significant historic cultural materials were observed in 2005. No cultural materials were observed during the current examination of this area.
