Liquefaction-Induced Lateral Spreading in Oceano, California, During the 2003 San Simeon Earthquake

By Thomas L. Holzer[1], Thomas E. Noce[1], Michael J. Bennett[1], Carola Di Alessandro[1], John Boatwright[1], John C. Tinsley, III[1], Russell W. Sell[1], and Lewis I. Rosenberg[2]

Open-File Report 2004–1269

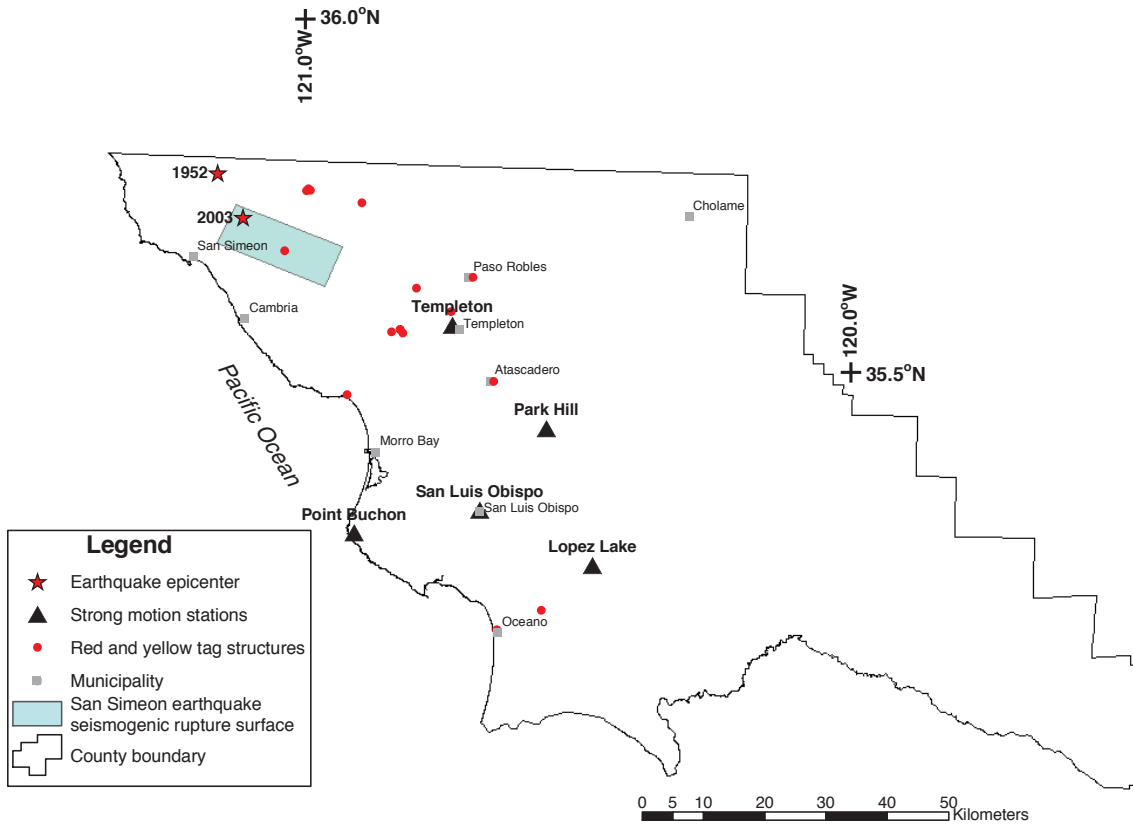
Figure 1. Map of San Luis Obispo County, California, with projected slip surface of San Simeon M6.5 earthquake (Hardebeck and others, 2004), epicenters of 1952 Bryson M6.2 and 2003 San Simeon M6.5 earthquakes, strong motion stations along general azimuth from the 2003 earthquake to Oceano, and buildings with red and yellow tags in unincorporated areas.

Main-shock recordings at the five strong-motion stations that were located between the M6.5 rupture area and Oceano indicate that ground motion was relatively strong in the direction from the fault rupture towards Oceano (Figure 1). The stations range from Templeton, which was only 20 km from the rupture area, to Lopez Lake, which was 67 km from the end of the rupture, at approximately the same distance as Oceano. Three of these stations, Templeton, Point Buchon, and Lopez Lake, are operated by the California Strong Motion Instrumentation Program, while the San Luis Obispo and Park Hill stations, respectively, are operated by the USGS National Strong Motion Program and TriNet. Values of PGA recorded at four of these five stations are significantly larger than the average values for reverse fault earthquakes as regressed by Boore and others (1997) (Figure 9). Boatwright and Seekins (2004) attribute the higher level of shaking to directivity associated with the unilateral fault rupture to the southeast during the main shock. They show that PGA's recorded at stations to the southeast of the main shock exceed PGA's recorded at stations at comparable distances to the northwest by a factor of about three.

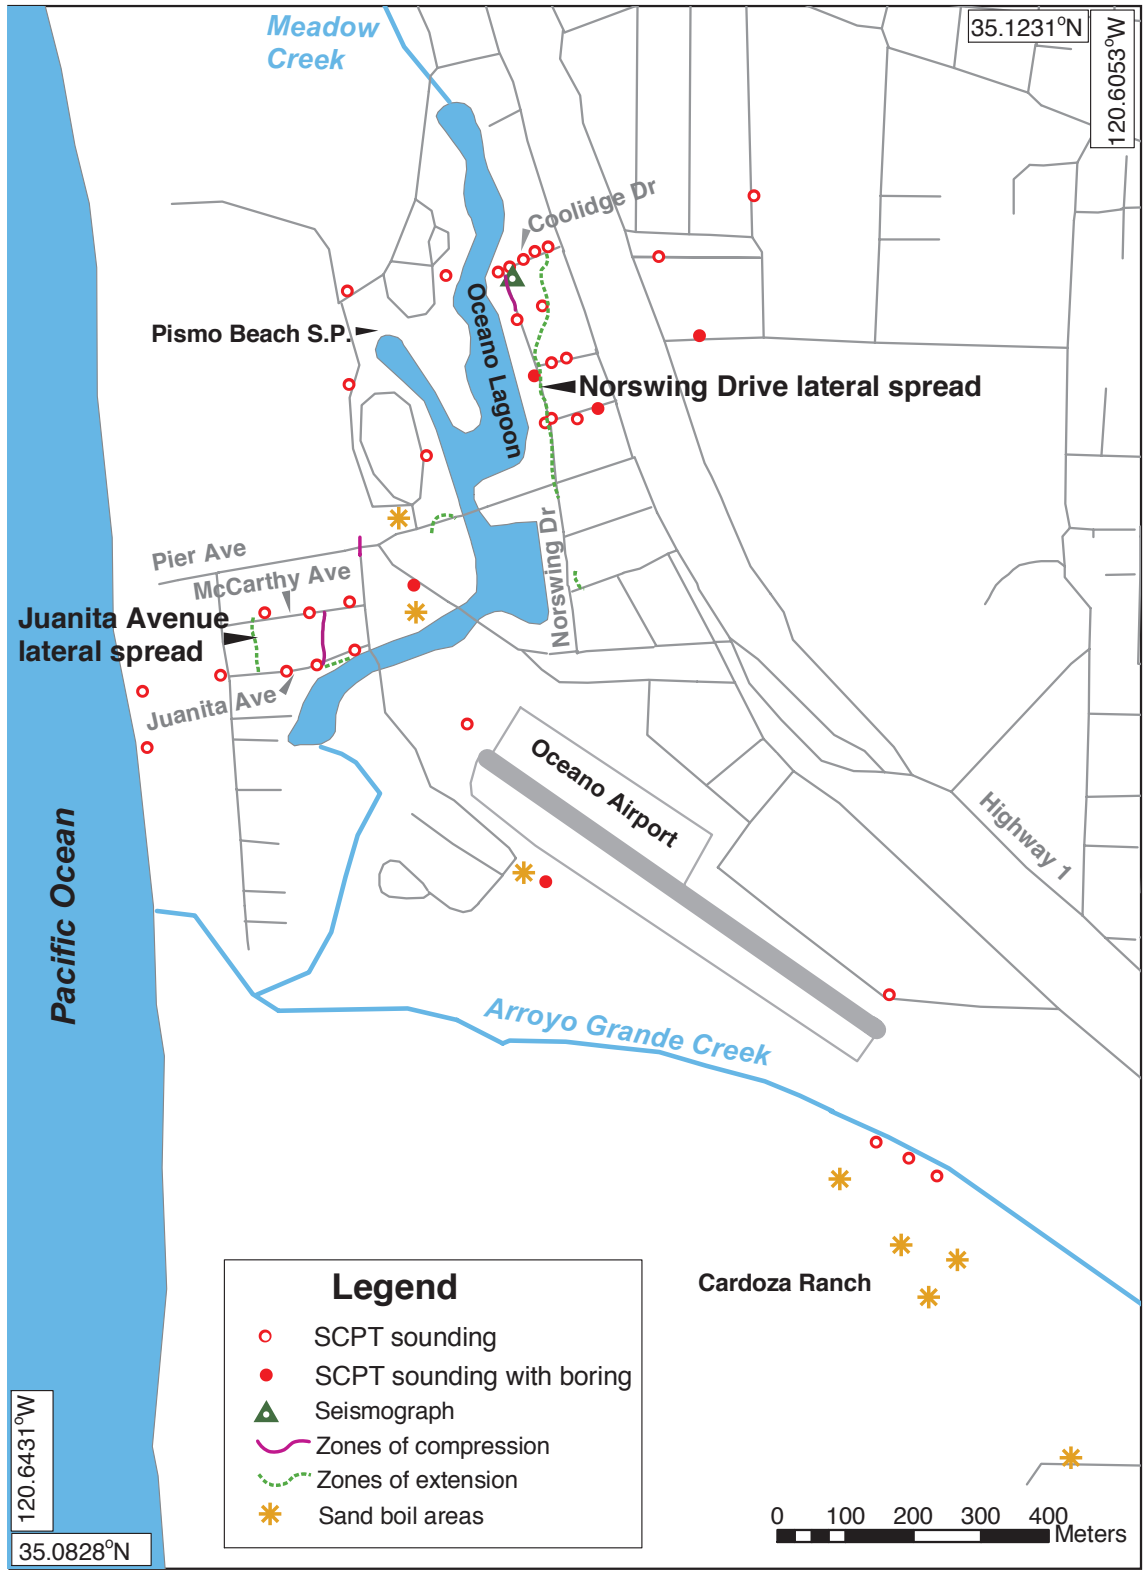
Figure 3. Map of Oceano, California, area with ground failure and liquefaction areas, USGS SCPT soundings and borings, and portable digital seismograph.

In addition to these two lateral spreads, several smaller ground failures and lateral spreads were observed (Figure 3). The most significant of these was a bearing capacity failure that damaged the southern levee of Arroyo Grande Creek at Cardoza Ranch, where sand boils also erupted over a large area in the ranch pasture to the south of the levee. A rare eyewitness account of this liquefaction was transcribed by one of the authors on January 5, 2004, from the recollection of Pat Cardoza. Mr. Cardoza, who owns

and Juanita Avenue lateral spreads, permanent ground deformation, and sand boils were observed at many locations. These additional liquefaction effects were not mapped in detail by the USGS, but they were noted at the Oceano airport, along Pier Avenue, in Pismo Beach State Park, and at the Cardoza Ranch (Figure 3).

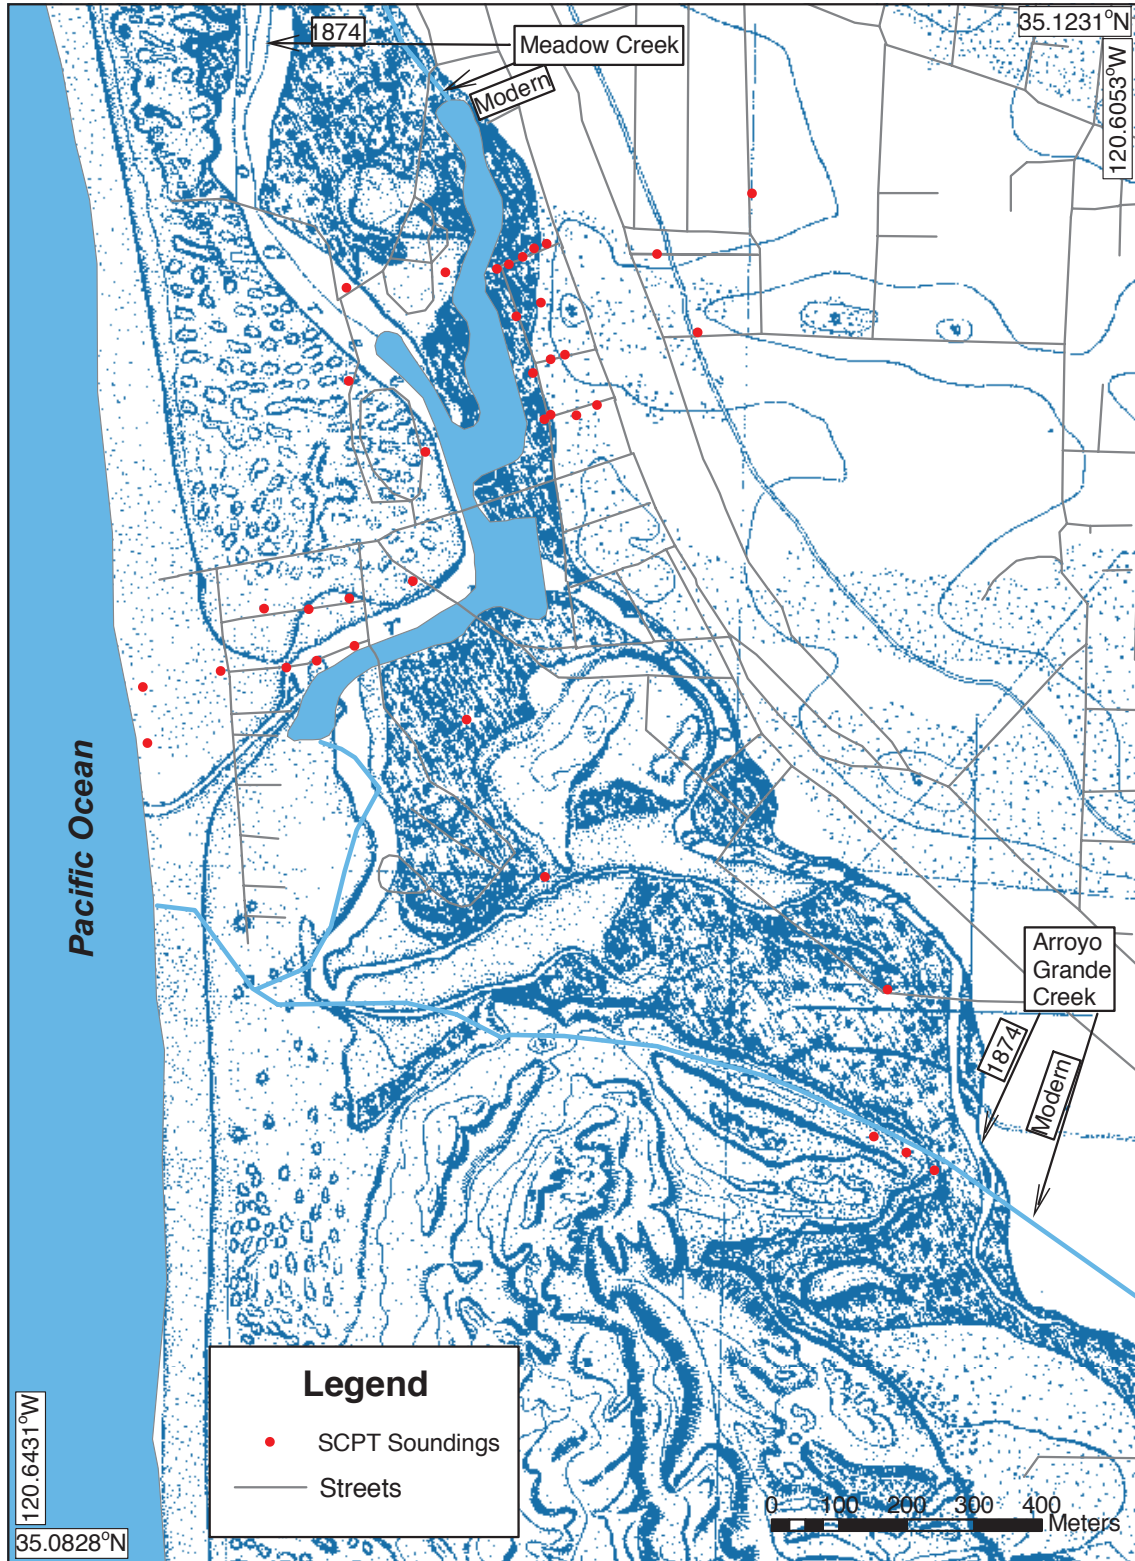
Predevelopment surficial geologic and subsurface conditions in Oceano can be inferred from the 1873-1874 U.S. Coast Survey T-sheet 1393 (Figure 4). It reveals that the undisturbed surficial geology at Oceano was varied. Surficial deposits included fields of active to inactive sand dunes, marsh and tidal estuarine deposits, floodplain sediments deposited by Arroyo Grande and Meadow Creeks, and beach deposits along what is now Strand Way. Perhaps the most striking feature on the T-sheet is the extensive marsh along Meadow and Arroyo Grande Creeks. Most of this marsh has been filled in, with the modern lagoon on Meadow Creek (Oceano Lagoon) being the only remaining trace. Unpublished historical subdivision maps in the files of San Luis Obispo County show that the Norswing Drive and Juanita Avenue lateral spreads originally were within an area

Figure 4. Oceano portion of 1873-1874 U.S. Coast Survey T-sheet 1393 with road network, modern hydrography (in light blue), and locations of USGS SCPT soundings superimposed. Stippled pattern denotes sandy areas including dune fields. Dark pattern denotes marshes along Meadow and Arroyo Grande Creeks.

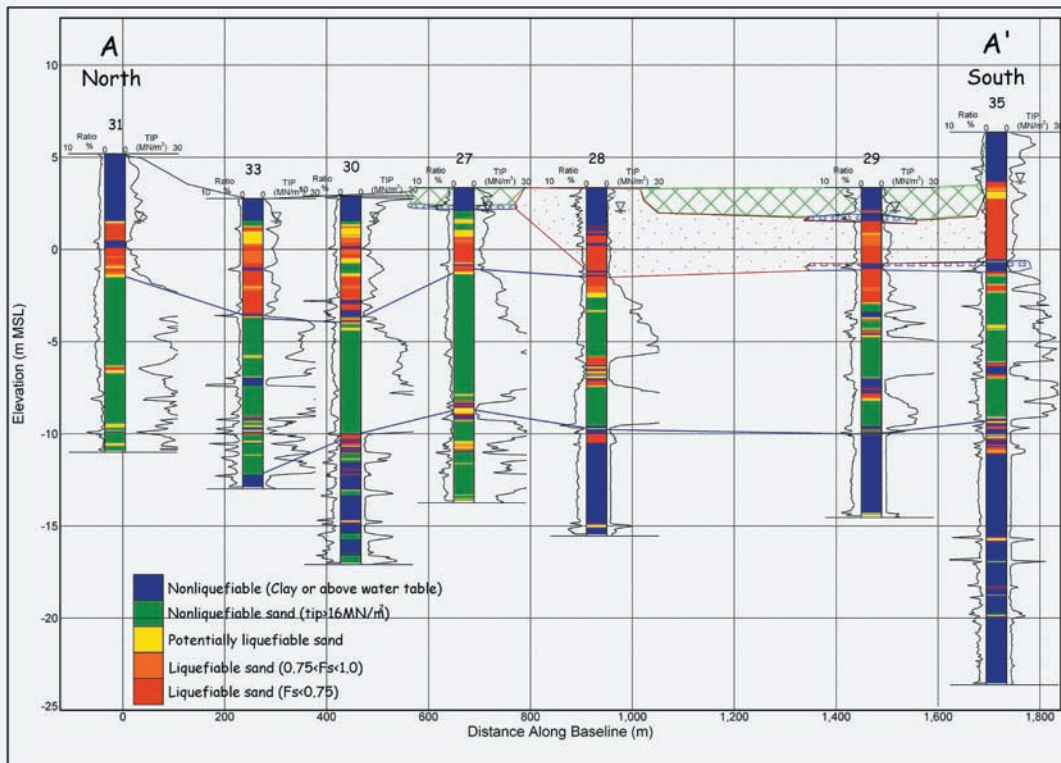
Figure 6a.

Figure 6. North-south cross section (A-A') at Oceano of generalized shallow subsurface conditions based on SCPT soundings. See Figure 5 for location of cross section. Cross section includes profiles of CPT tip and friction ratio, geologic units, and water table with (a) shear-wave velocity (V_S), (b) liquefaction factors of safety for a M6.5 and PGA=0.25 g, and (c) liquefaction factors of safety for a M6.8 and PGA=0.4 g.

Analyses of the liquefaction potential at SCPT soundings in the two cross sections across Oceano are consistent with these field observations (Figures 6b and 7b). The analyses indicate that much of Oceano is underlain by sediment that is susceptible to liquefaction and predict that significant portions of the susceptible sediment liquefied in the 2003 earthquake. For each sounding in these cross sections (Figures 6b and 7b), factors of safety against liquefaction were computed for a M6.5 earthquake with PGA = 0.25 g, which is the approximate seismic loading that we infer for the 2003 earthquake. Intervals where liquefaction is predicted, i.e., factors of safety are less than one, are shown in red (FS $\leq$ 0.75) and orange (0.75 < FS < 1.0). Intervals where factors of safety were greater than one, but would be susceptible to liquefaction at higher levels of ground shaking, are shown in yellow. Approximately 10 to 75 percent of the intervals susceptible to liquefaction are predicted to have liquefied, i.e., FS < 1.0. Much of the sediment that is predicted either to have liquefied or to be susceptible to liquefaction is the artificial fill and undisturbed (natural) eolian or fluvial sediment.

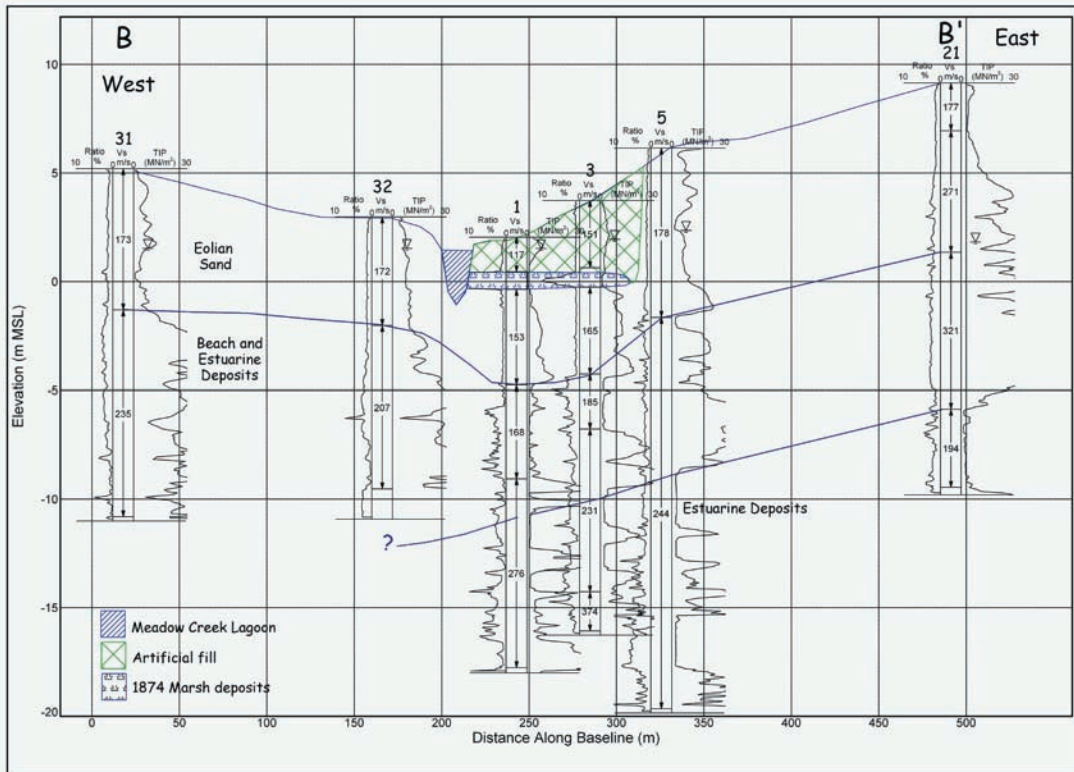
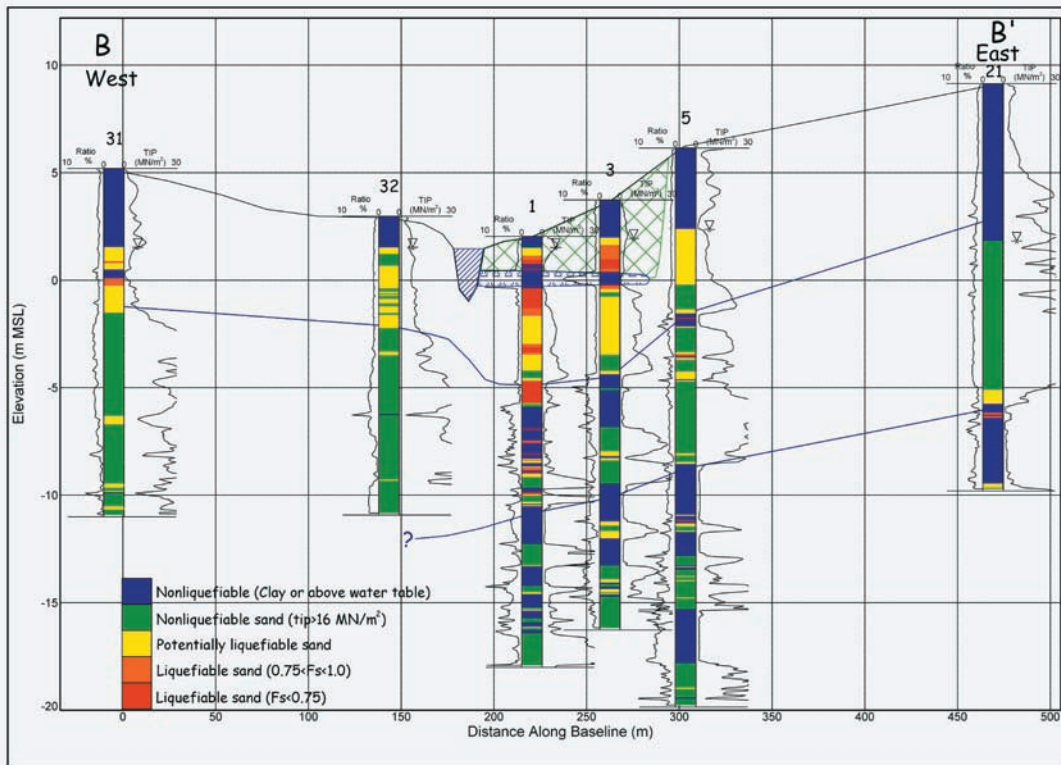
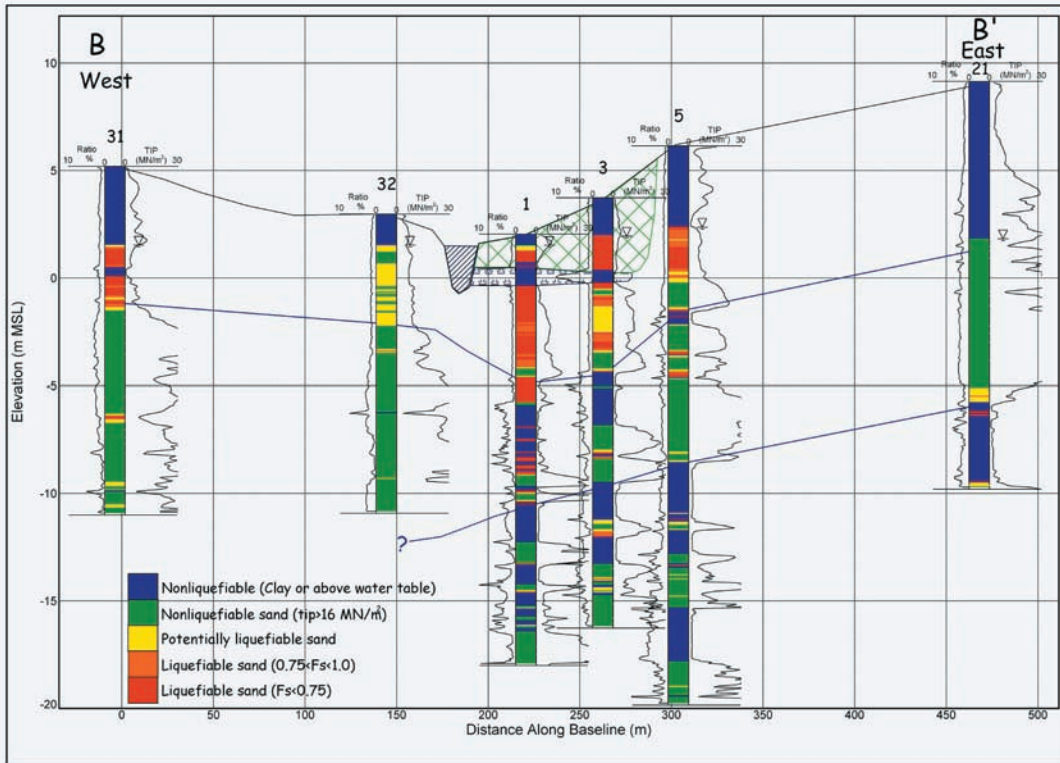
Figure 7. East-west cross section (B-B') at Oceano of generalized shallow subsurface conditions based on SCPT soundings. See Figure 5 for location of cross section. Cross section includes profiles of CPT tip and friction ratio, geologic units, and water table with (a) shear-wave velocity (V_s), (b) liquefaction factors of safety for a M6.5 and PGA=0.25 g, and (c) liquefaction factors of safety for a M6.8 and PGA=0.4 g.

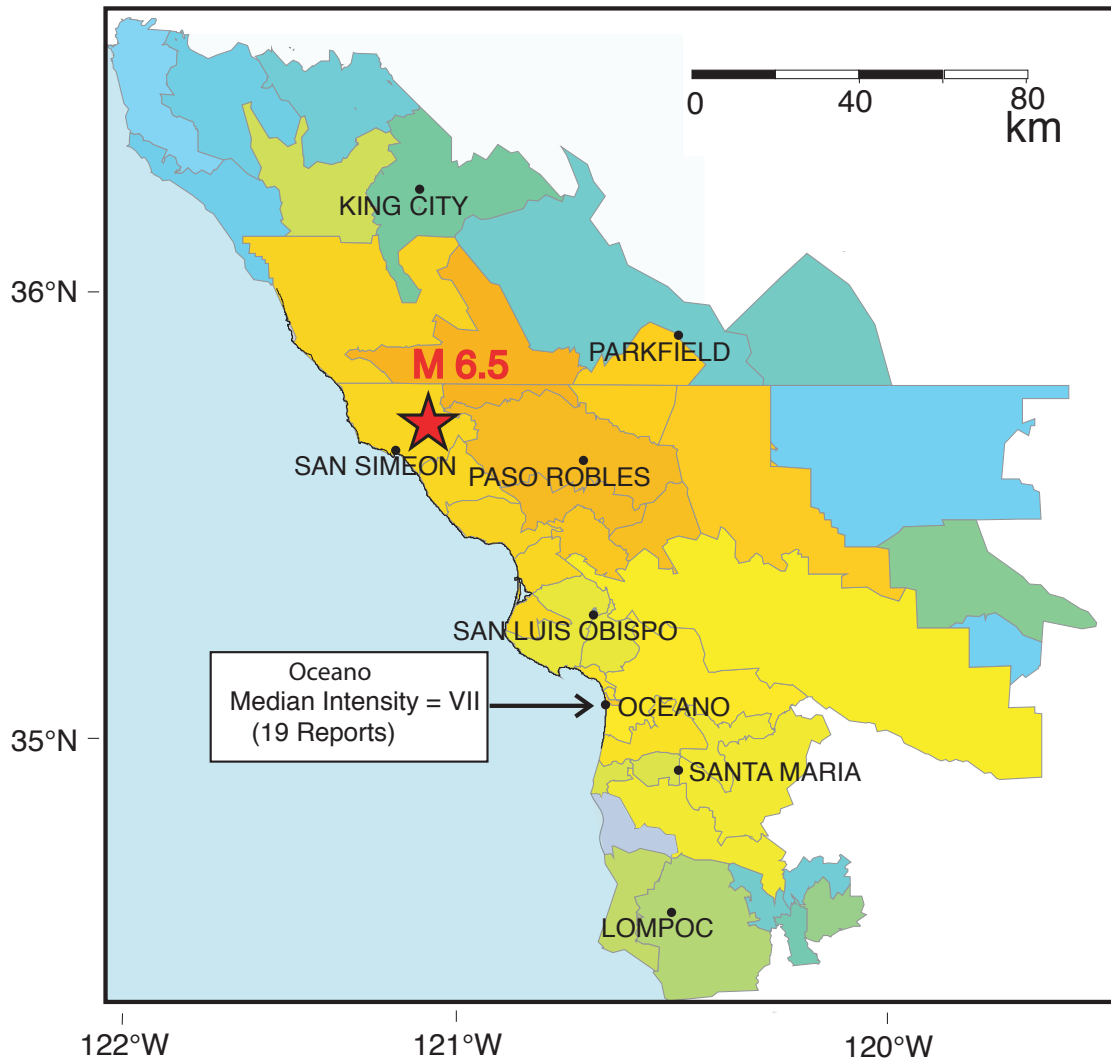
Oceano and the surrounding communities immediately after the earthquake (Figure 8). The 21 responses from the Oceano zip code reported a median Modified Mercalli Intensity (MMI) of VII, which Wald and others (1999) associate with peak ground accelerations (PGA) that range from 0.18 to 0.32 g. Median intensities reported in nearby zip codes range from MMI V to VI, corresponding to PGA's that range from 0.04 to 0.18 g. Thus, both the damage and high intensity reported at Oceano suggest shaking were unexpectedly high.

Figure 8. USGS Community Intensity Map for the 2003 San Simeon M6.5 earthquake. Oceano had 21 reports with a median Modified Mercalli Intensity of VII. Modified from map posted at http://pasadena.wr.usgs.gov/shake/ca/STORE/X40148755/.

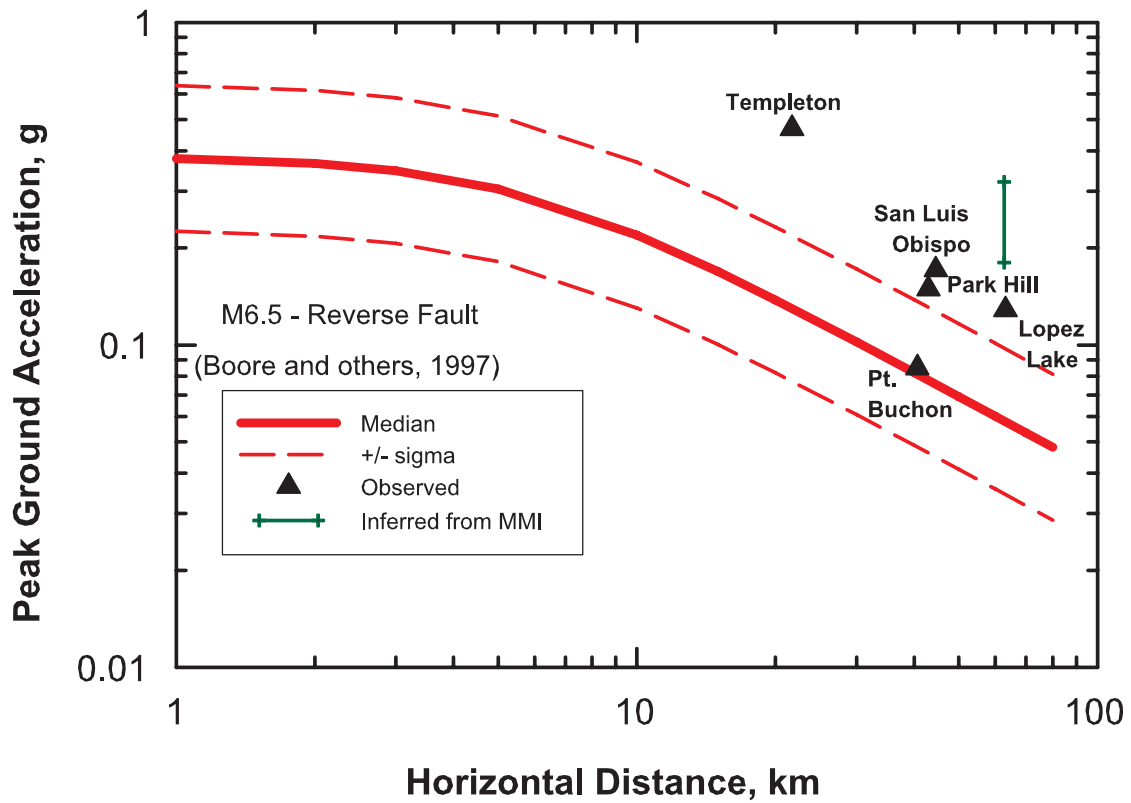
Figure 9. Median ($\pm\sigma$) PGA estimated for soft rock sites (V_{S30}=750 m/s) for a M6.5 reverse fault earthquake (Boore and others (1997). PGA values recorded at strong motion stations along general azimuth from the 2003 San Simeon earthquake to Oceano are also shown. See Figure 1 for locations. Range of PGA inferred from USGS "Did you feel it?" also shown.

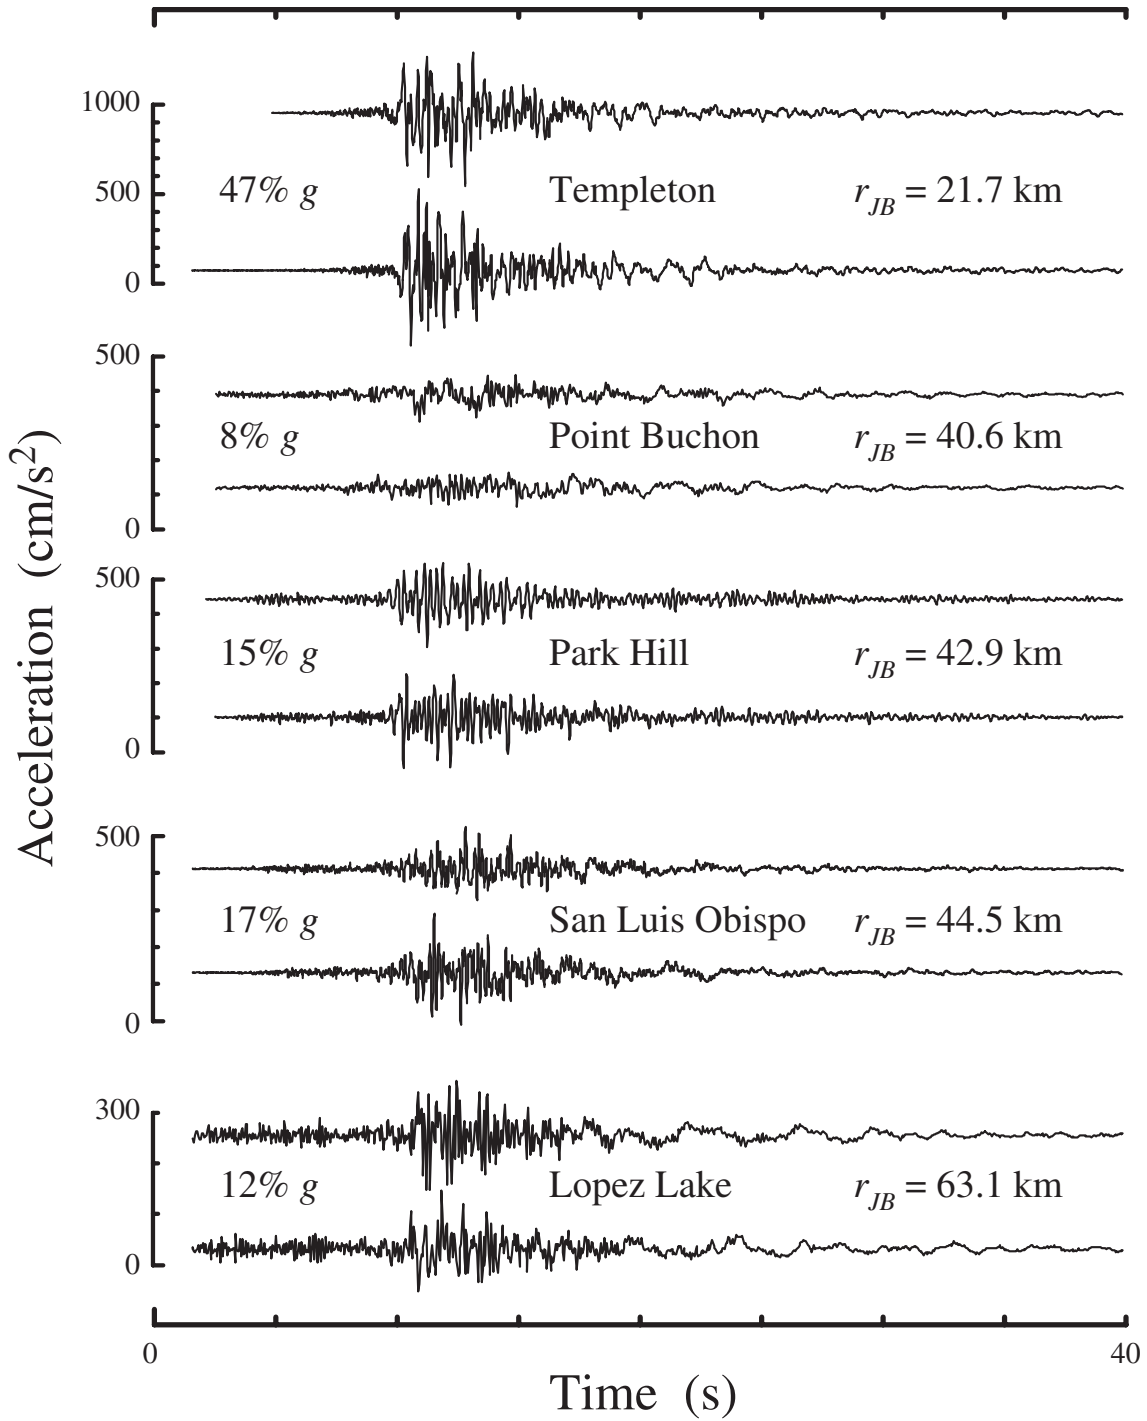
The recordings of the main shock at the five stations along the southeast azimuth are generally similar in duration; differences in amplitude and frequency content can be attributed to variations in local geologic conditions (Figure 10). To compare these recordings more directly, we correct for the effect of distance from the earthquake source by scaling the acceleration amplitudes by the distance between the station and the closest surface projection of the fault (the "Joyner-Boore distance" devised by Joyner and Boore (1981)). This scaling emphasizes the similarity between the accelerograms. The Point Buchon accelerogram is the least similar, and also has the lowest scaled acceleration. The Templeton accelerogram (PGA=0.47 g) has the largest scaled accelerations, and the Lopez Lake accelerogram (PGA=0.12 g) has the second largest. If the ground motion depended only on the distance to the rupture, we could use the recording (PGA=0.12 g) at Lopez Lake as an analog for Oceano. Because all five stations are at the same approximate azimuth from the rupture, the variation in scaled amplitude largely reflects differences in local geologic conditions. Point Buchon and Park Hill are sited on soft rock whereas Templeton and Lopez Lake are sited on stiff soil. Although San Luis Obispo occupies a sediment-filled valley, the station does not appear to be sited on soft deep soil similar to Oceano.

Figure 10. Horizontal ground accelerations recorded at strong motion stations along general azimuth from the 2003 San Simeon earthquake to Oceano. Amplitudes are scaled for distance from fault rupture.

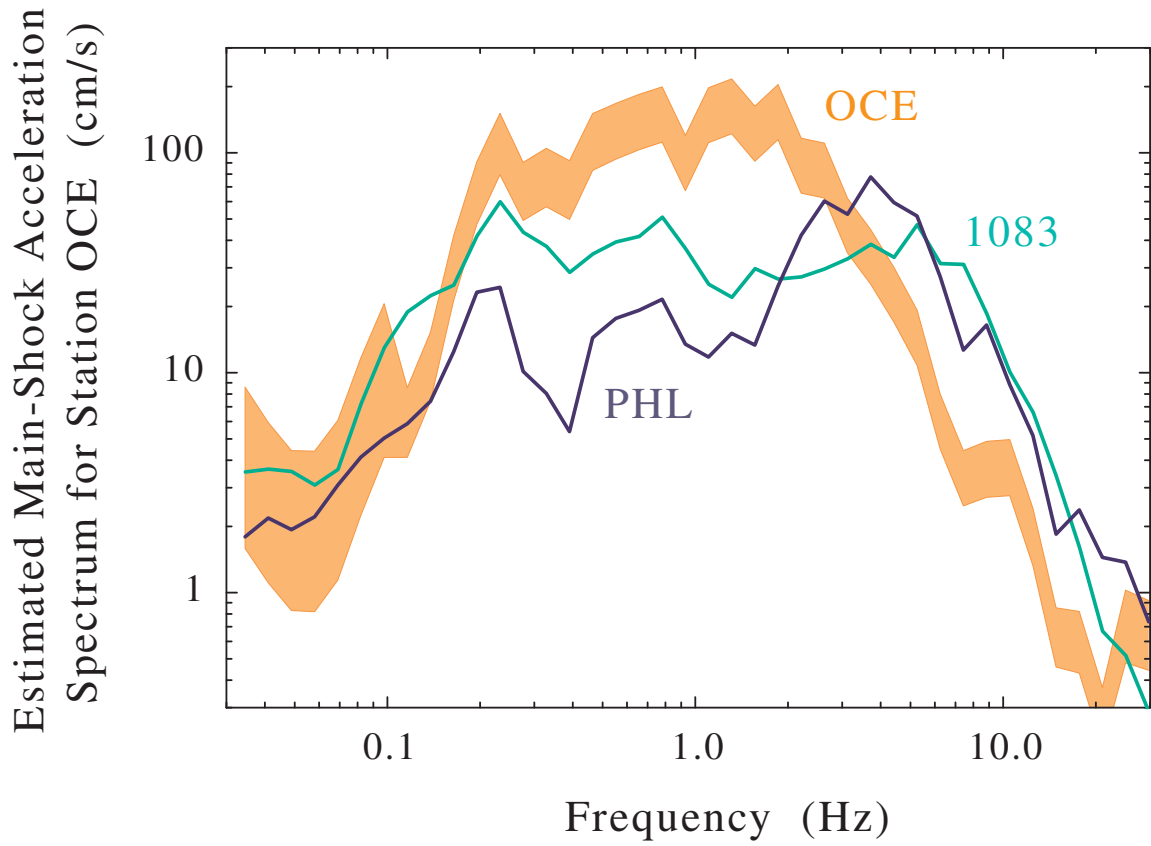
Combined horizontal acceleration spectra for the Park Hill and San Luis Obispo recordings are plotted in Figure 11 along with the combined estimated horizontal acceleration spectrum for Oceano. Amplification at Oceano is significant; the estimated main-shock spectrum for Oceano exceeds the recorded spectra at Park Hill and San Luis Obispo over the frequency band from 0.2 to 3 Hz, despite being 20 km further from the rupture area. This relative amplification compares favorably with the higher "Did you feel it?" intensities reported at Oceano for the main shock.

Figure 11. Combined horizontal acceleration spectra for the Park Hill (PHL) and San Luis Obispo (1083) strong motion recordings and the estimated combined horizontal acceleration spectra for Oceano (OCE).

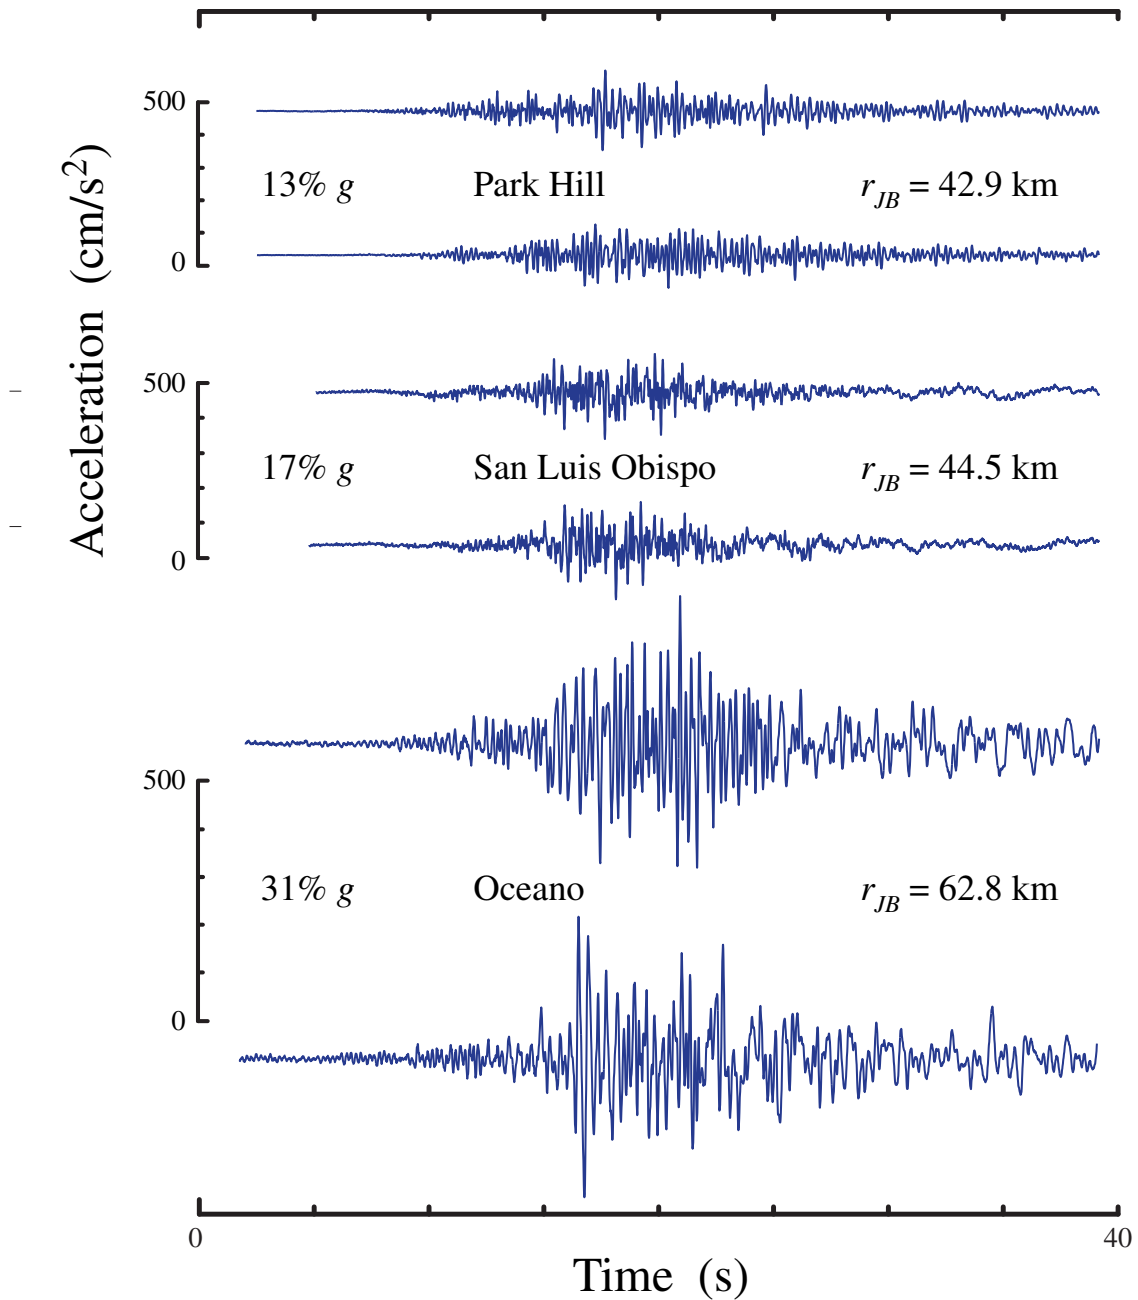
To estimate PGA at Oceano during the main shock, synthetic accelerograms were computed using the method proposed by Boore (2003). The method combines the spectral ratio of the main shock to an aftershock with the horizontal accelerograms for that same aftershock and a stochastic operator. We estimate the operator duration as 1 s by using the same technique to fit the main-shock accelerograms from San Luis Obispo and Park Hill. The resulting synthetic accelerograms are plotted in Figure 12. This technique estimates that the main-shock PGA was 0.29 ± 0.04 g at Oceano, where the variability is derived from the set of different realizations of the stochastic operator. As in the previous method of spectral ratios, the soil at Oceano is assumed to have behaved linearly during the main shock. Thus, the estimate is an upper bound for the PGA.

Figure 12. Synthetic main-shock horizontal ground accelerations at Park Hill, San Luis Obispo, and Oceano scaled for distance from fault rupture based on the February 27, 2003, M3.8 aftershock. The PGA values indicated correspond to the stochastic realization plotted in the figure rather than the average PGA given in the text. Note the correspondence of the synthetic accelerogram for San Luis Obispo with the recorded accelerogram shown in Figure 10.

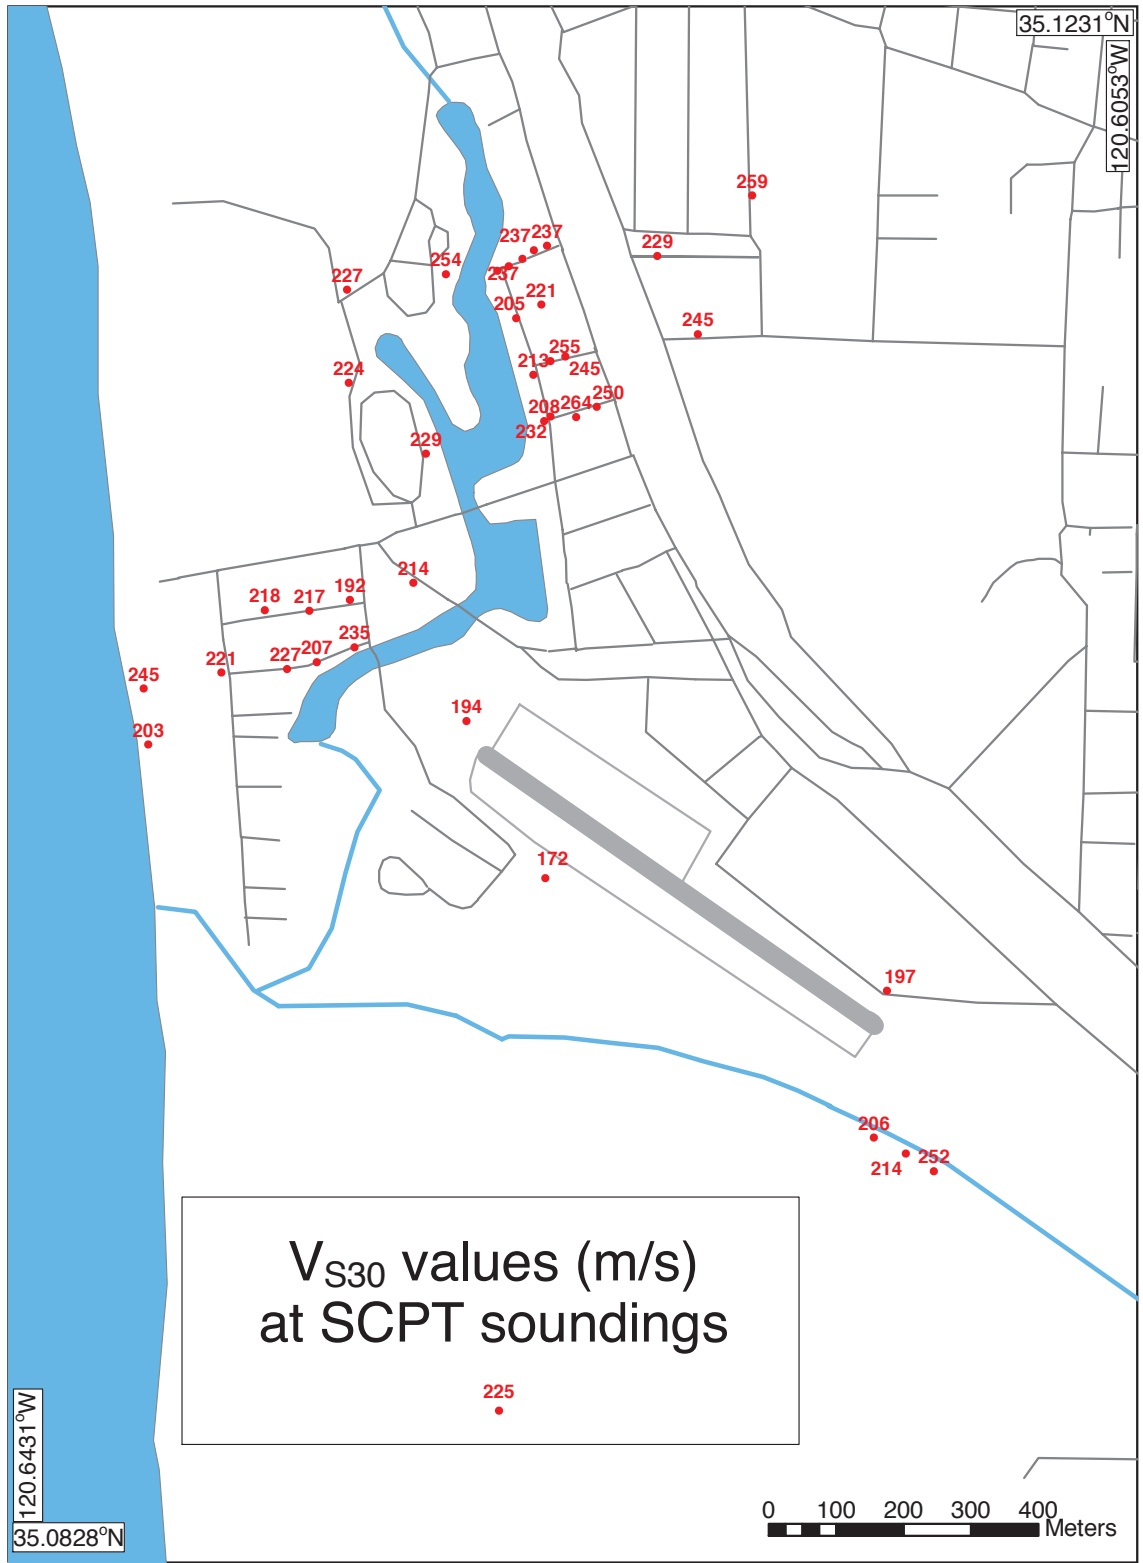
Shear-wave velocity measured in the SCPT soundings indicate that Oceano is underlain by soil type D ($180<V_{S30}<360$), which has the second highest amplification (Figures 13 and 14). The average V_{S30} is 224 m/s (±21 m/s) and ranges from 172 to 264 m/s. Values of V_{S30} were estimated because most SCPT soundings reached depths of only approximately 20 m. To estimate V_{S30}, we assumed that the velocity measured in the lower part of the sounding characterized the depth interval between the bottom of the sounding and 30 m. The extrapolation is reasonable because the Pleistocene unconsolidated sediment penetrated by deep water wells at Oceano is approximately 100-m thick (Weber and Hanamura, 1970); therefore, abrupt velocity changes in the upper 30 m are unlikely.

Figure 13. Map of V_{S30} values inferred from USGS SCPT soundings.

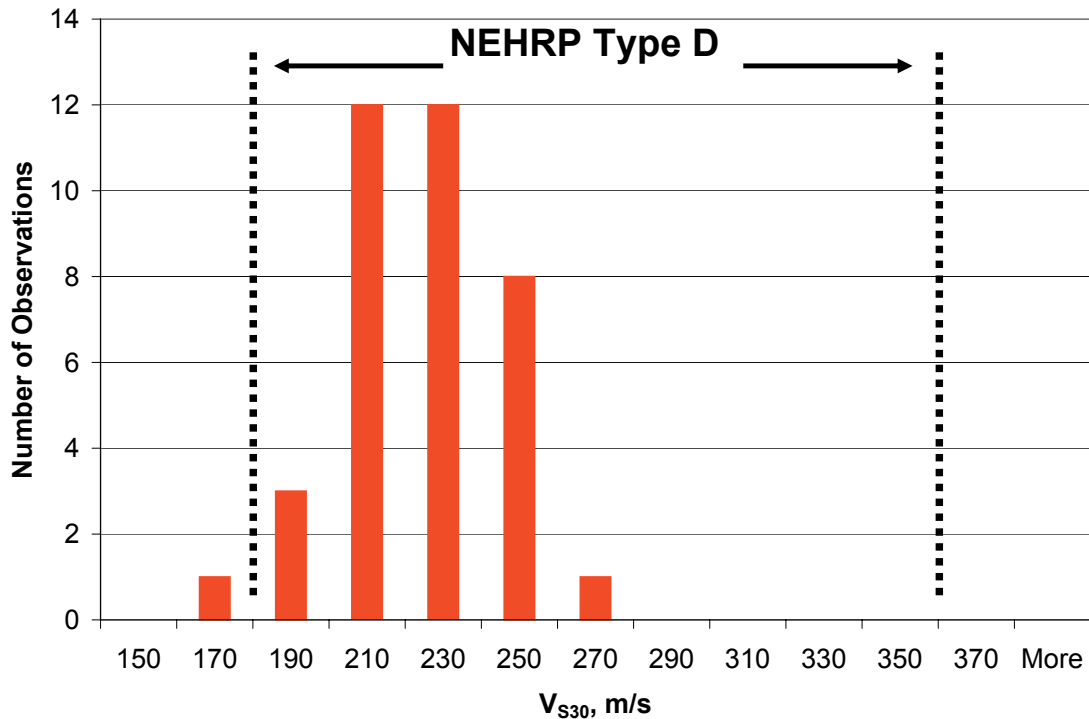
Figure 14. Histogram of V_{S30} values inferred from USGS SCPT soundings. Range of V_{S30} for NEHRP site class D is from BSSC (2001).

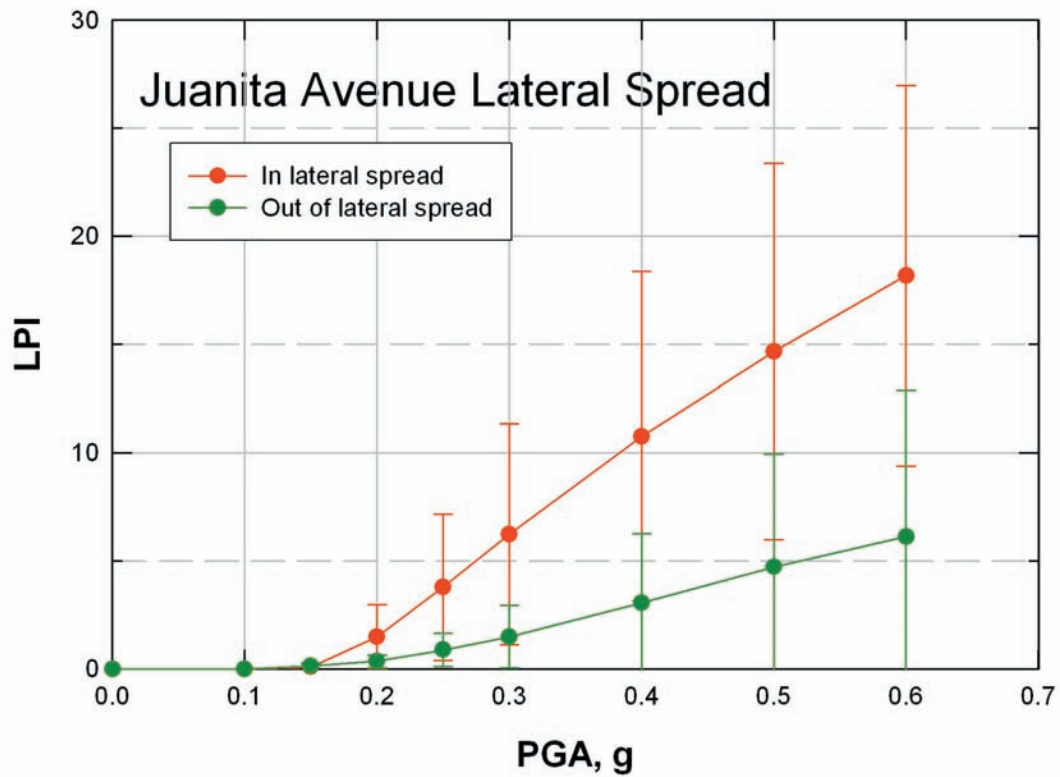
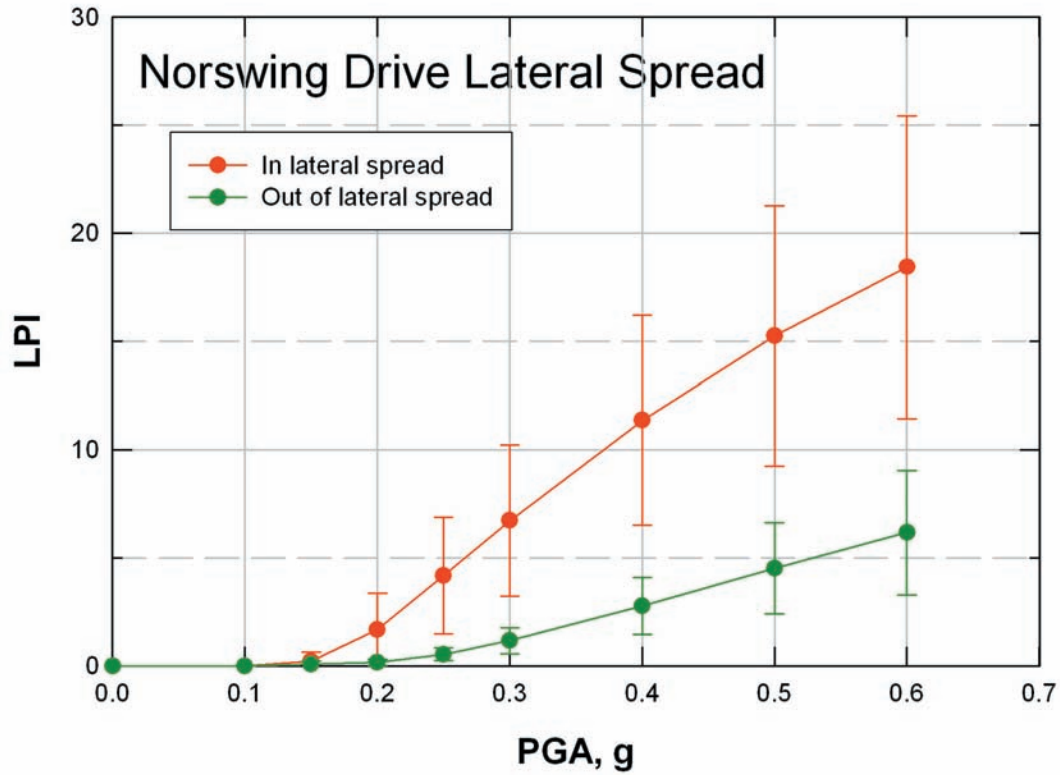
Comparison of mean LPI values measured in and out of the lateral spreads at each lateral spread provides a synoptic view of the liquefaction potential (Figure 15). Mean LPI values were obtained by classifying soundings as either in or out of the lateral spread area, and then computing the mean value (at each PGA) for each group of soundings. Mean LPI values for soundings in the lateral spread are generally higher than the mean value for soundings outside of the lateral spread. This implies that the sediment at each lateral spread is more susceptible to liquefaction than is the sediment outside of the lateral spread.

Figure 15 also indicates that for a M6.5 earthquake, a PGA of at least 0.25 g is required to produce an average LPI value of 5 at the Oceano lateral spreads. This is a lower bound estimate based on the threshold LPI value at which surface manifestations of liquefaction are observed (Toprak and Holzer, 2003). The value is slightly smaller than the PGA of 0.29 g, which is an upper bound estimate, inferred for the main shock from the analysis of the M4.5 aftershock recorded at Oceano. Both values fall within the range of PGA values inferred from the USGS "Did you feel it? Web site statistics, 0.18 to 0.32 g. The three estimates are compared in Figure 16. The lower bound estimate of PGA=0.25 g is used for subsequent analyses of liquefaction potential caused by the 2003 San Simeon earthquake.

Figure 15. (a) Mean LPI values ($\pm \sigma$) for soundings in and out of the Norswing Drive lateral spread; (b) Mean LPI values for soundings in and out of the Juanita Avenue lateral spread. Values were computed for a M6.5 earthquake and different levels of PGA.

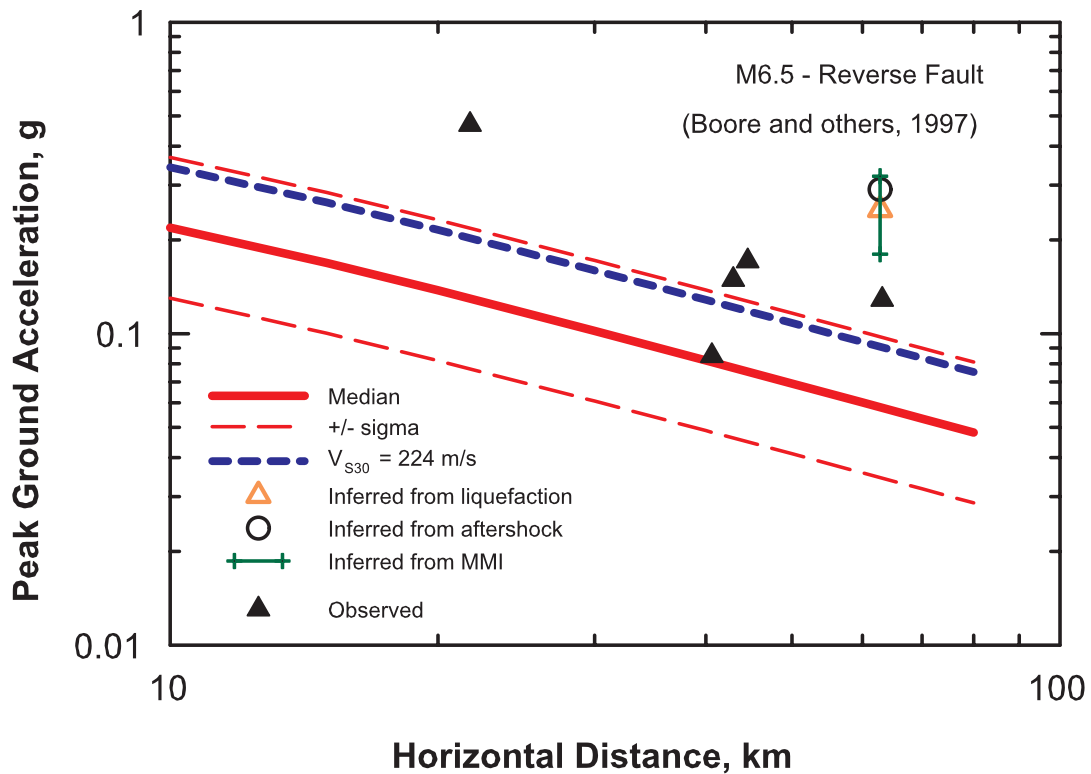
Figure 16. Comparison of PGA values at Oceano inferred from aftershocks, liquefaction, and felt intensity with recorded PGA values and median ($\pm\sigma$) PGA estimated for soft rock site condition (V_{S30}=750 m/s) for a M6.5 reverse fault earthquake (Boore and others, 1997).
