Liquefaction-Induced Lateral Spreading in Oceano, California, During the 2003 San Simeon Earthquake

By Thomas L. Holzer[1], Thomas E. Noce[1], Michael J. Bennett[1], Carola Di Alessandro[1], John Boatwright[1], John C. Tinsley, III[1], Russell W. Sell[1], and Lewis I. Rosenberg[2]

Open-File Report 2004–1269

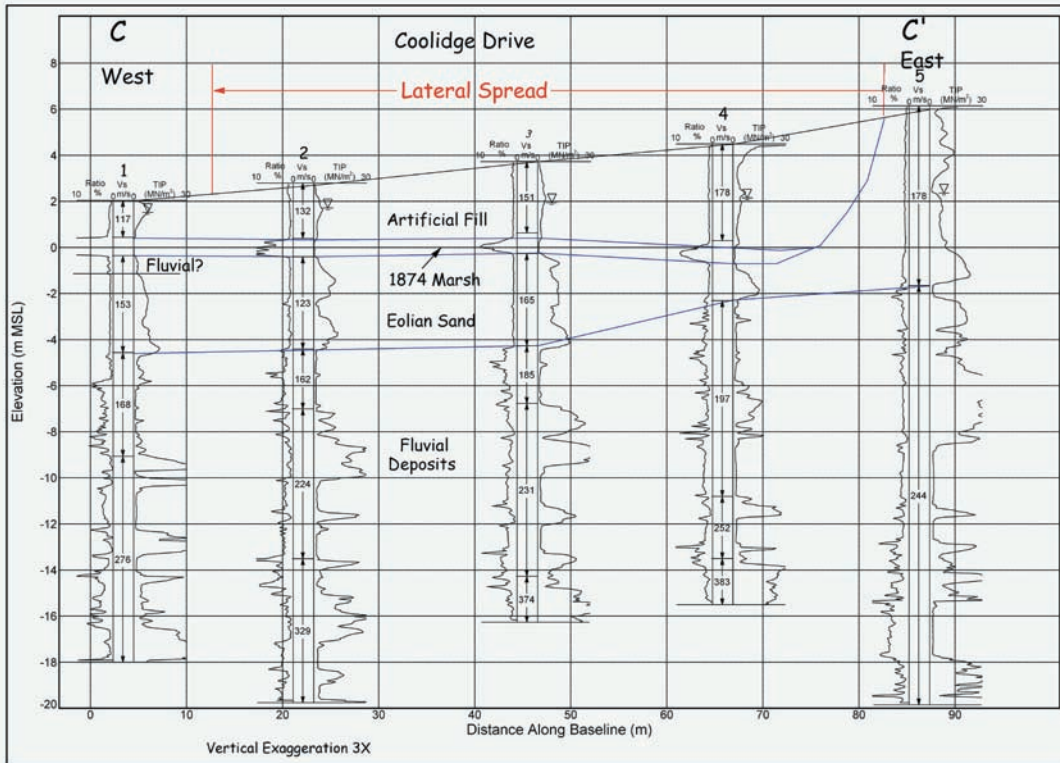
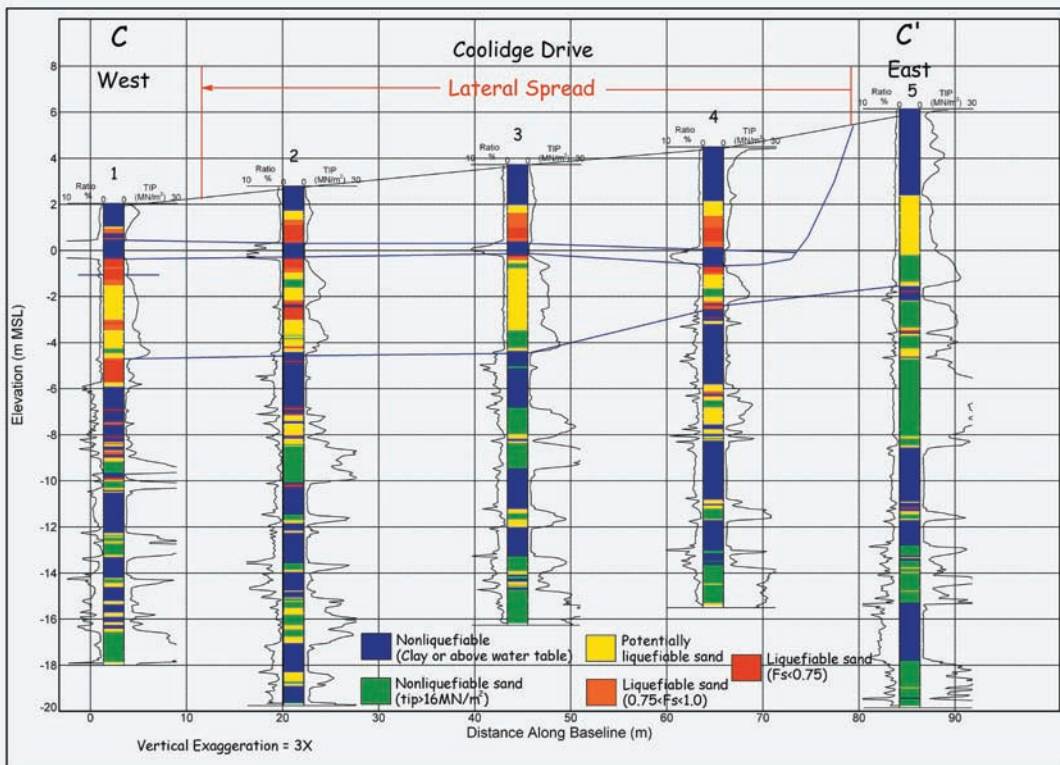
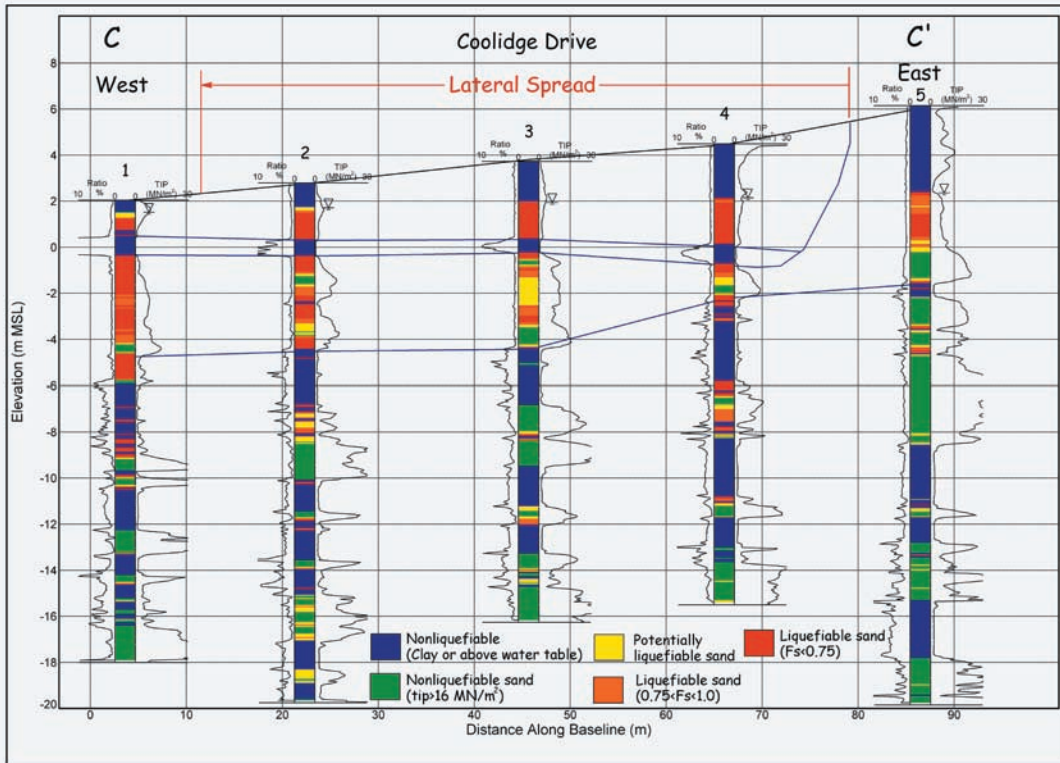
Figure 17a.

Cross sections of both lateral spreads document the cause of the contrast of liquefaction resistance in and out of the lateral spread (Figures 17 and 18). The cross section across the Norswing Drive lateral spread is along Coolidge Drive (see Figure 4, C-C' for location) and the cross section across the Juanita Avenue lateral spread is along Juanita Avenue (see Figure 4, D-D' for location). The upper panel (a) in each figure shows the SCPT penetration profiles and shear-wave velocities. The middle panel (b) shows predicted factors of safety at each sounding for the M6.5 San Simeon earthquake and a PGA=0.25 g. The lower panel (c) shows predicted factors of safety for a scenario earthquake to be discussed later.

The cross section of the Norswing Drive lateral spread (Figure 17a), indicates that the lateral spread is coincident with the clean sandy artificial fill that was placed over the 1874 marsh. An approximately 1- to 1.5-m-thick interval where predicted factors of safety are less than one (red and orange) can be traced beneath the lateral spread at the base of the artificial fill, which suggests that the lateral spread is associated with liquefaction of artificial fill (Figure 17b). The head scarp–the eastern boundary–of the lateral spread is coincident with the eastern margin of the artificial fill; the toe of the

lateral spread–the western boundary–appears to be determined by the decreased thickness of saturated artificial fill. Although liquefaction is predicted in some of the undisturbed eolian sand beneath the 1874 marsh layer, it is unclear that this liquefaction significantly contributed to the Norswing Drive lateral spread deformation. The inference about the significance of liquefaction in the artificial fill beneath Coolidge Drive, is consistent with factors of safety computed in the other soundings–SOC012, SOC015, and SOC017–in the Norswing Drive lateral spread. Factors of safety in all three soundings predict that most of the liquefaction occurred in the artificial fill.

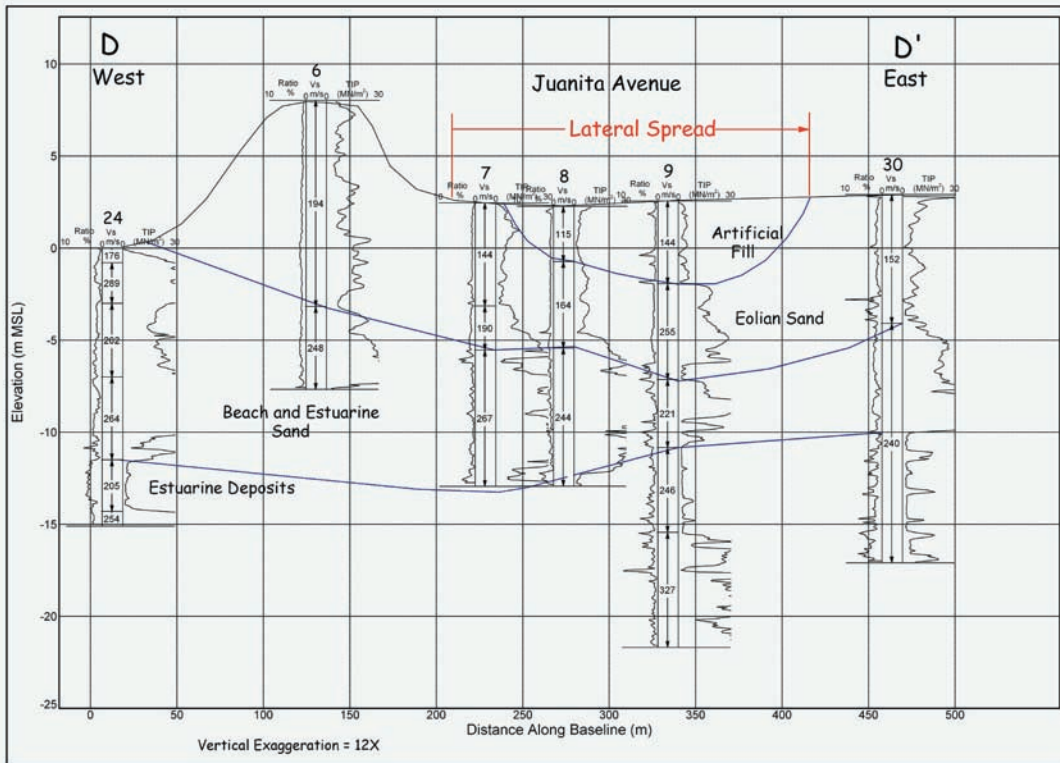
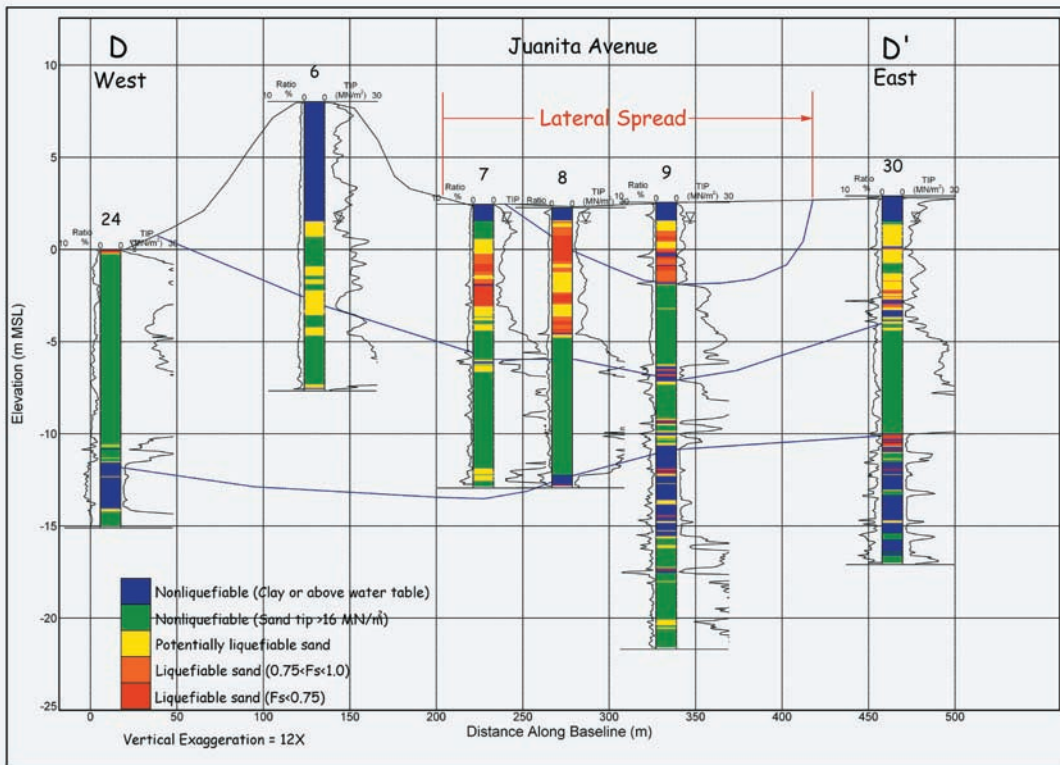
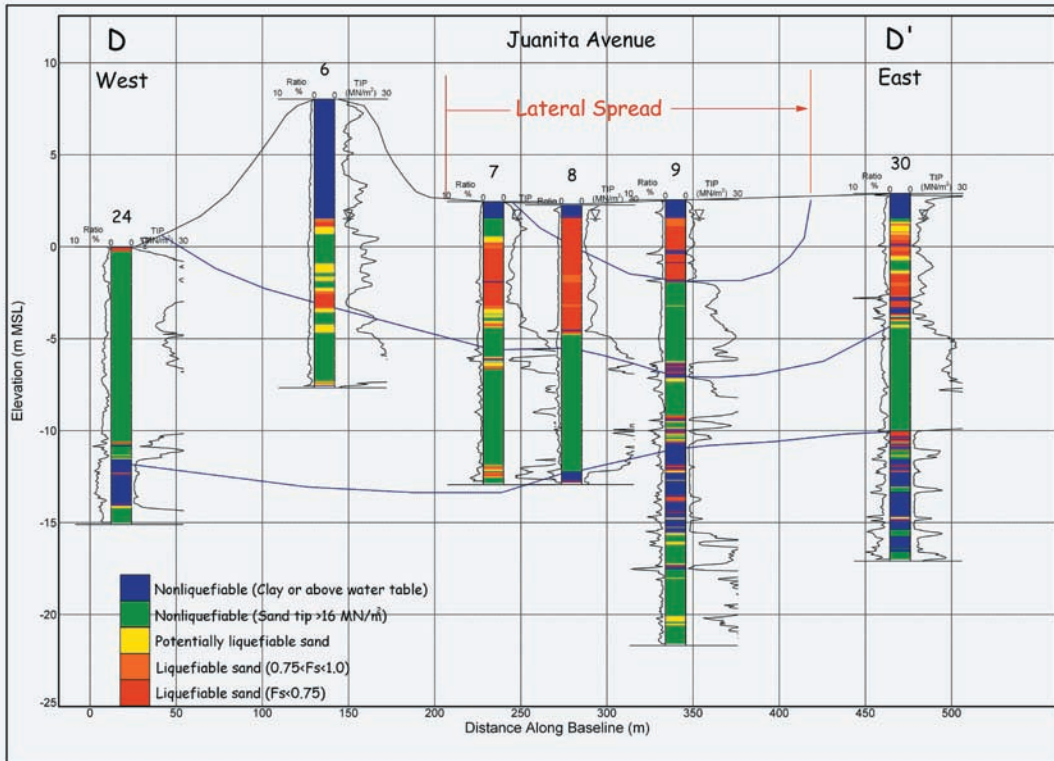
Figure 18c.

Figure 18. Cross section D-D' of Juanita Avenue lateral spread along Juanita Avenue. See Figure 5 for location. Cross section includes profiles of CPT tip and friction ratio, geologic units, and water table with (a) shear-wave velocity (V_s), (b) liquefaction factors of safety for a M6.5 and PGA=0.25 g, and (c) liquefaction factors of safety for a M6.8 and PGA=0.4 g.

The cross section of the Juanita Avenue lateral spread (Figure 18a) also indicates that artificial fill liquefied and contributed to the lateral spreading. However, predicted factors of safety in the cross section indicate undisturbed eolian sediment beneath the artificial fill also contributed to the lateral spreading (Figure 18b). This is indicated in the cross section where the western boundary of the lateral spread is interpreted to overlie undisturbed eolian sand. The contribution of liquefaction in undisturbed eolian deposits to the lateral spreading is supported by analyses of McCarthy Avenue soundings SOC022, SOC025, and SOC026. Artificial fill is either thin or absent on McCarthy Avenue and the liquefaction is interpreted to be occurring in undisturbed eolian sediment. Thus, the Juanita Avenue lateral spread appears to be caused by liquefaction of both artificial fill and undisturbed eolian deposits.

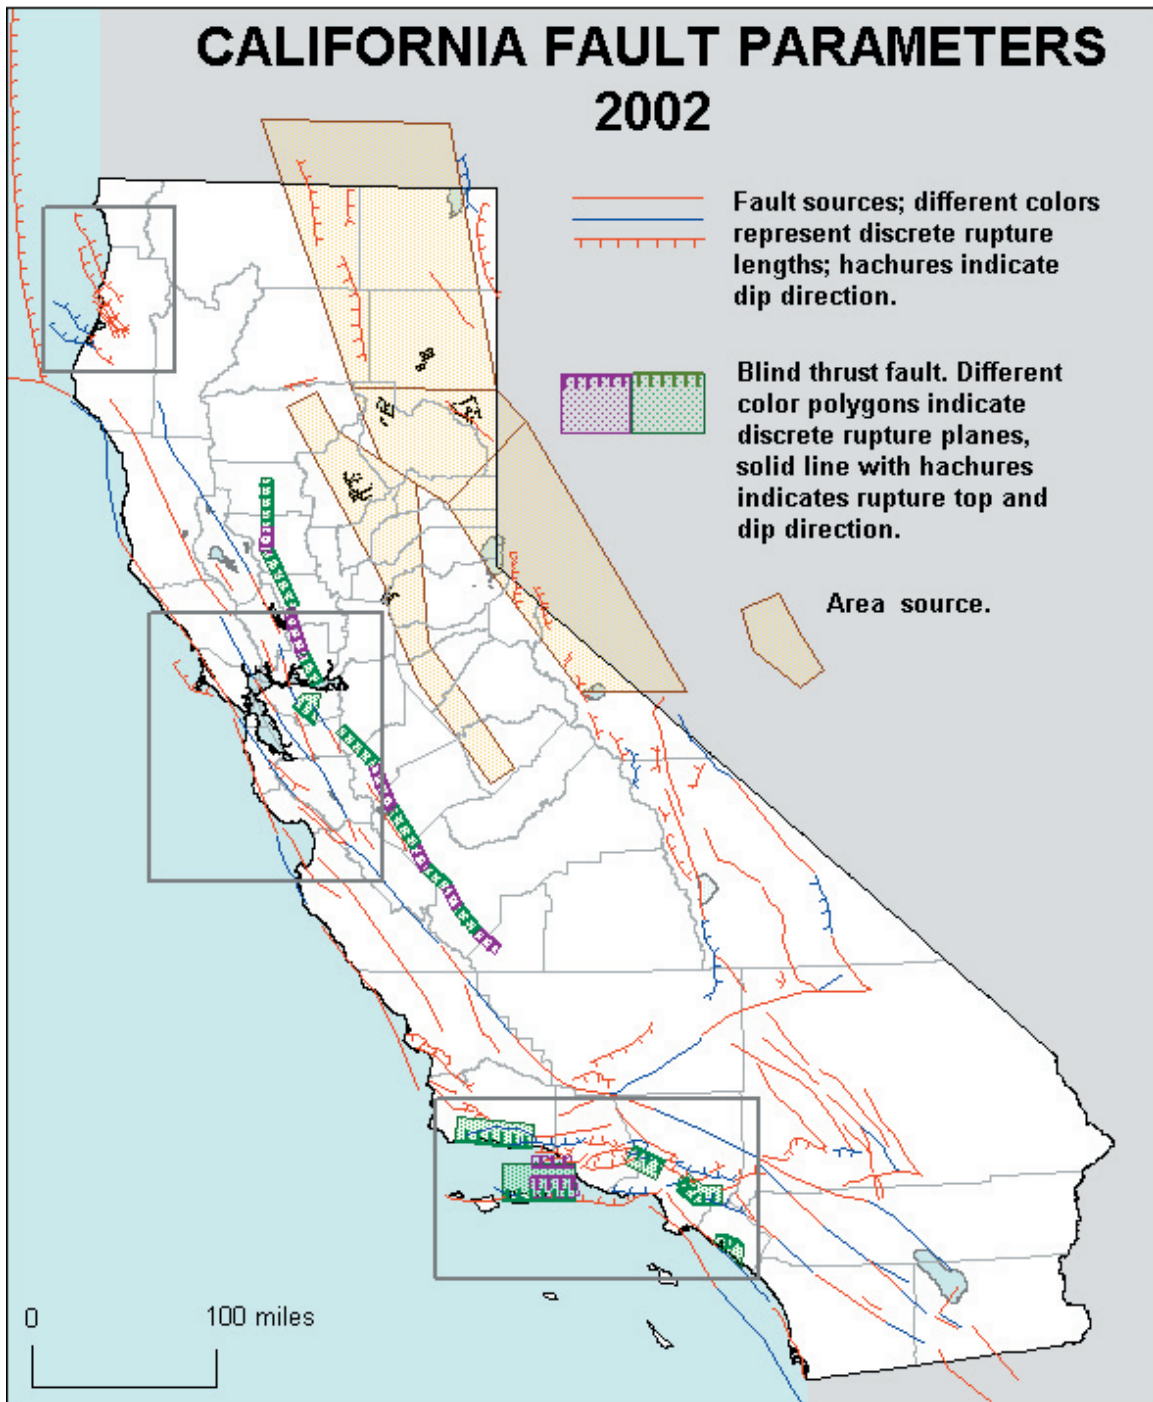
Figure 19 shows the locations of faults that the USGS and CGS characterized as active and that they used to estimate the shaking hazard for the California region of the National Seismic Hazard Map. The earthquake potential of the faults is summarized by Petersen and others (1996). Three active faults are particularly relevant to Oceano because of their proximity. From west to east, they are the Hosgri, Los Osos, and Rinconada Faults. The better known San Andreas Fault is approximately 45 km to the east of Oceano. Of the first three faults, the Los Osos Fault, which is a southwest dipping

Figure 19. Map of active faults in California used for the USGS National Seismic Hazard Map (http://www.consrv.ca.gov/CGS/rghm/psha/fault_parameters/htm/_hidden/whole_state.png)

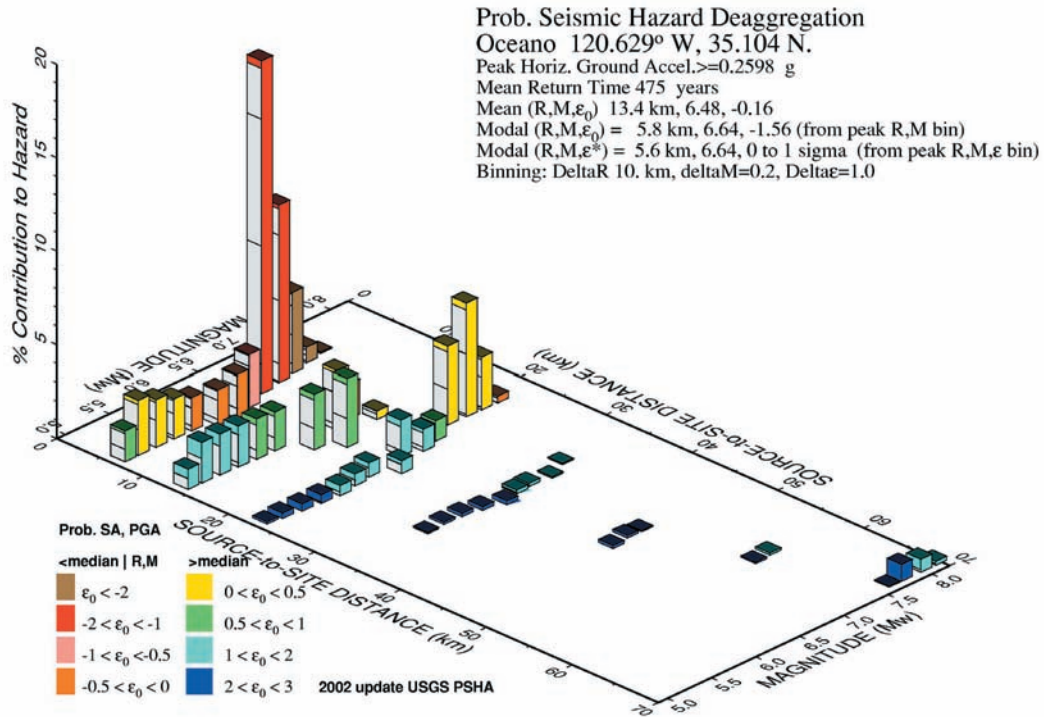
Figure 20. Deaggregated seismic hazard at Oceano for peak ground acceleration with a mean return time of 475 years. Hazard deaggregated from the USGS National Seismic Hazard Map. Graph was generated at http://eqhazmaps.usgs.gov. The faults contributing to the hazard at 5, 15, and 22 km, respectively, are the Los Osos, Hosgri, and Rinconada Faults.

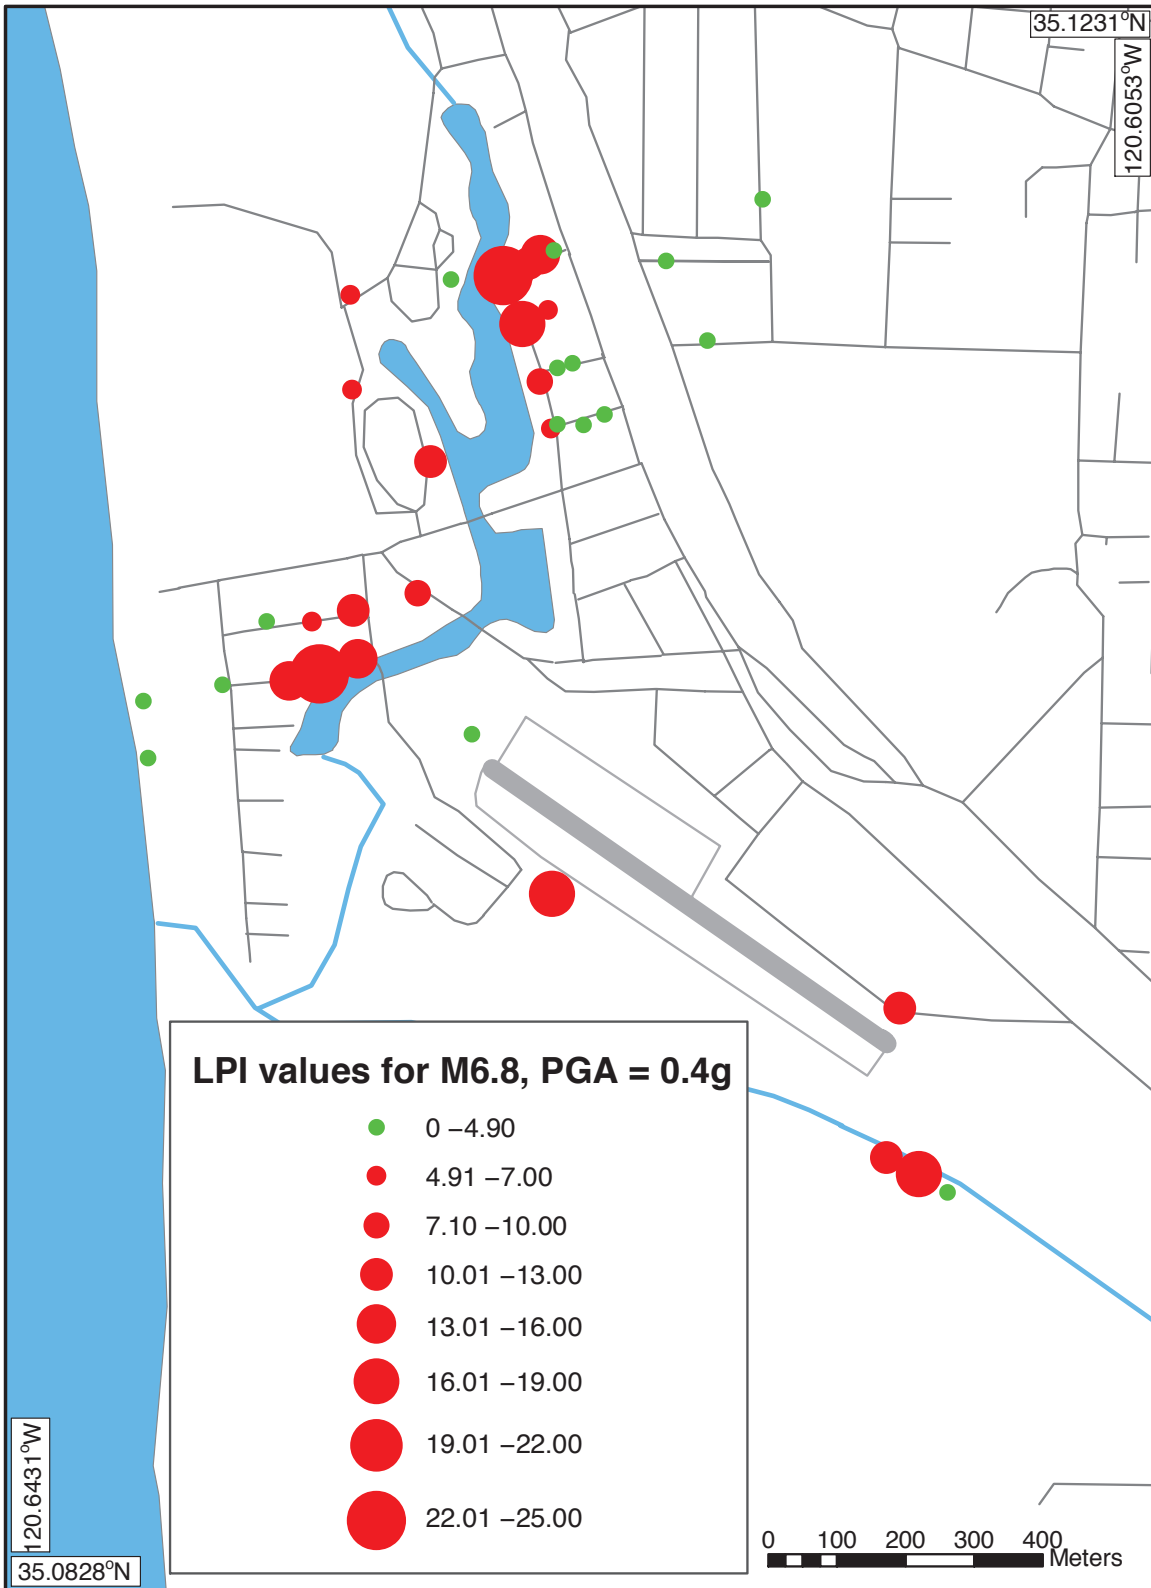
predicted to exhibit surface manifestations of liquefaction: the modern beach area and the area underlain by older sand dunes deposits east of Norswing Drive. Note that the predicted locations of liquefaction, i.e., LPI $\geq$ 5, for the San Simeon earthquake (Figure 21b) generally agree with locations of liquefaction observed in 2003 (Figure 2). Factors of safety for the soundings in the four cross sections, A-A' to D-D', are also shown for the Los Osos Fault scenario earthquake (Figures 6c, 7c, 17c, and 18c).

Figure 21. Map of LPI values for (a) M6.8 earthquake on the Los Osos Fault (PGA=0.4 g), and (b) the 2003 San Simeon M6.5 earthquake (PGA=0.25 g). Surface manifestations of liquefaction are expected where LPI ≥ 5.

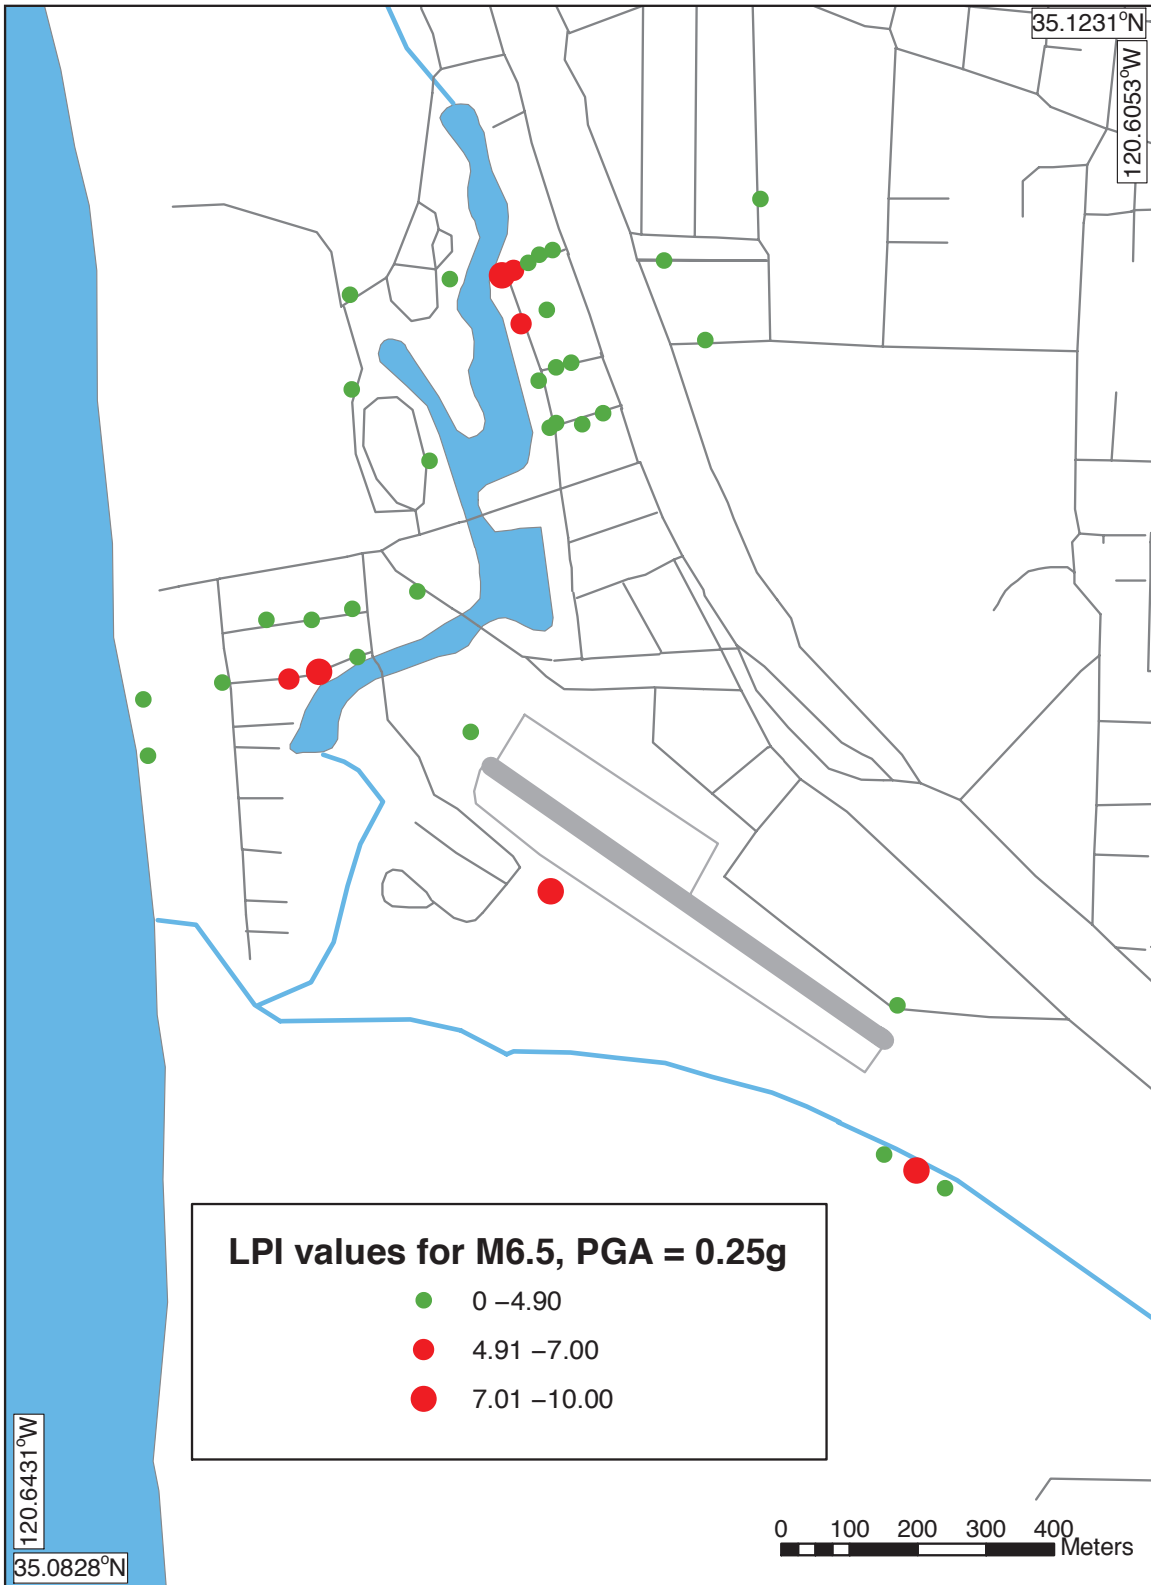
Figure 21b.

In addition to generating damaging ground shaking, a M6.8 earthquake on the Los Osos Fault is predicted to cause more liquefaction in Oceano than did the 2003 M6.5 San Simeon earthquake. This is illustrated in Figure 21a, which is a map of predicted LPI values for each SCPT sounding for a M6.8 earthquake on the Los Osos Fault with a PGA = 0.4 g. This level of ground shaking is predicted close to a M6.8 earthquake (see Boore and others, 1997). Comparison of maps of LPI for a Los Osos Fault scenario and for the 2003 San Simeon earthquake (Figure 21b) indicates that liquefaction for the M6.8 earthquake would be both more geographically widespread (areas where LPI $\geq$ 5) and more severe (higher values of LPI). Most of Oceano would exhibit surface manifestations of liquefaction from the nearby M6.8 earthquake. In fact, only two broad areas are not

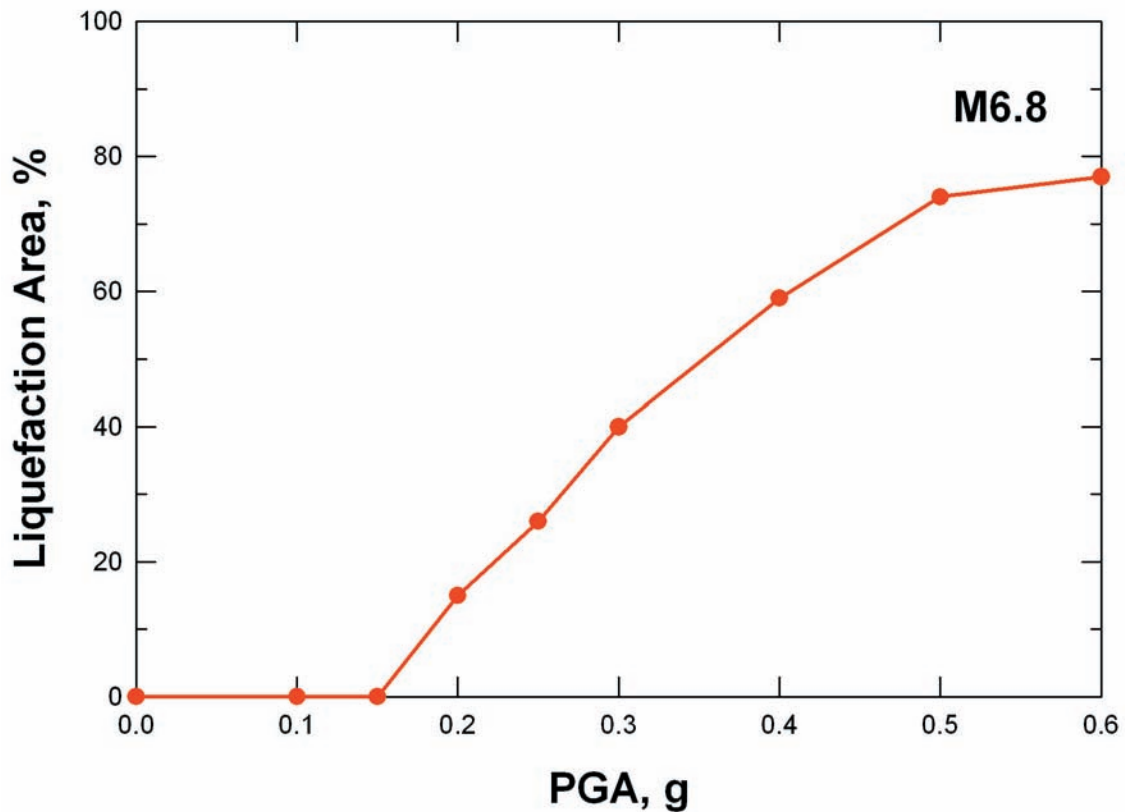
Although this USGS investigation was prompted by the large distance of Oceano from the San Simeon earthquake, the community also may be subjected some day to near-source ground motion. The nearby Los Osos Fault shows evidence of Holocene offset and is assumed to be capable of generating a M6.8 earthquake. If such an earthquake were to happen, higher levels of ground shaking and much more extensive liquefaction and severe lateral spreading would occur in Oceano than did in 2003.

Figure 22. Percent of area in Oceano predicted to exhibit surface manifestations of liquefaction during a M6.8 earthquake as a function of PGA.

- Avoidance of liquefaction hazard

- Special foundation design
